# TOWN OF BEDFORD

Municipal Facilities Master Plan and Space Needs Assessment

Volume One: Space Program, Existing Facility Assessments and  
Space Utilization Analysis Draft

August 03, 2017

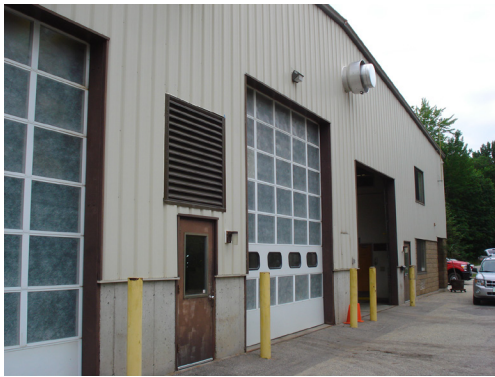
GRILLS/VENT FOR NEW CO SYSTEM

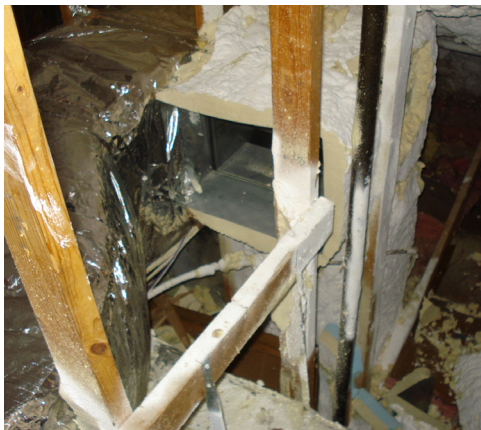
FOAM OVERSPRAY IN ATTIC

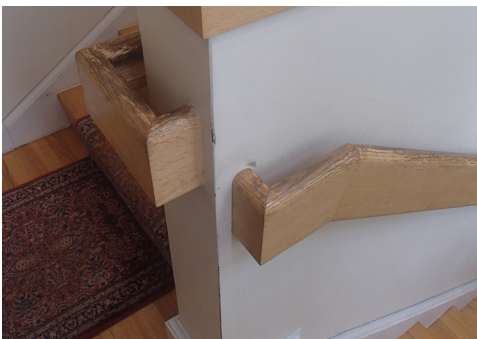
RAILING WEAR NON CONTINUOUS

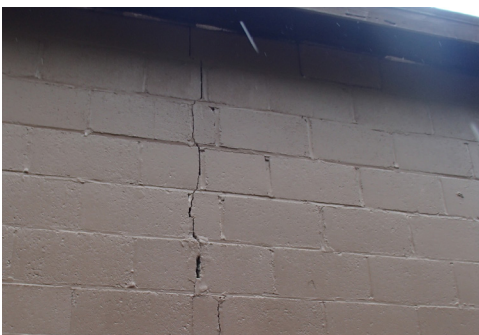
CRACK AT CMU WALL

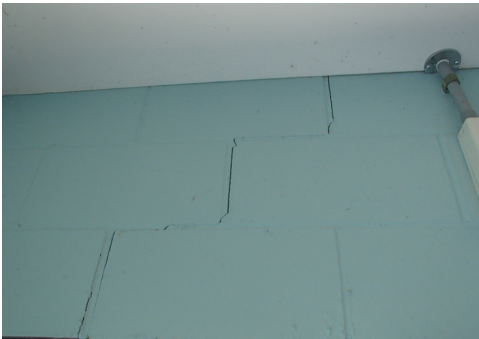
- Settlement cracks at interior CMU walls over door openings were observed.

INTERNAL CMU CRACK AT DOOR HEAD

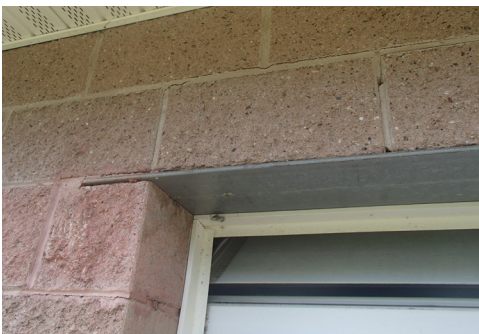
MORTAR CRACKS AT CMU

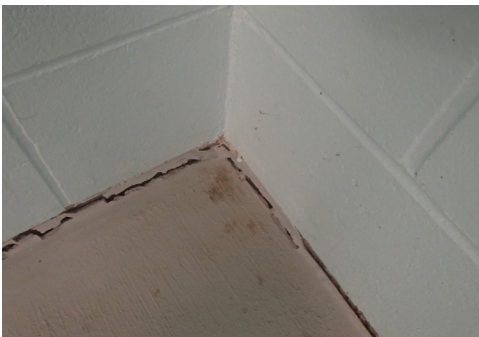
SEPARATION AT WALL AND FLOOR

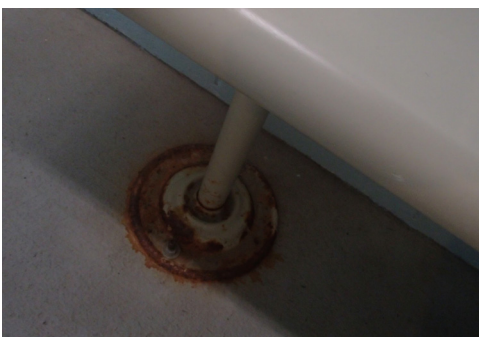
TYPICAL CORROSION AT BENCHES

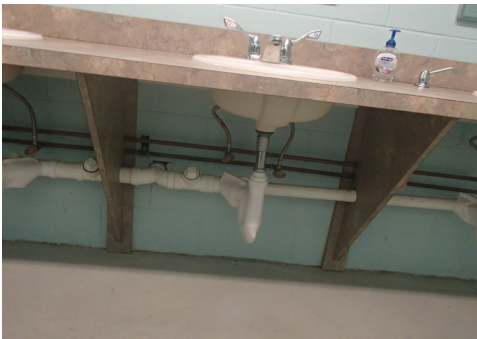
INSUFFICIENT ADA WRAP AT SINKS

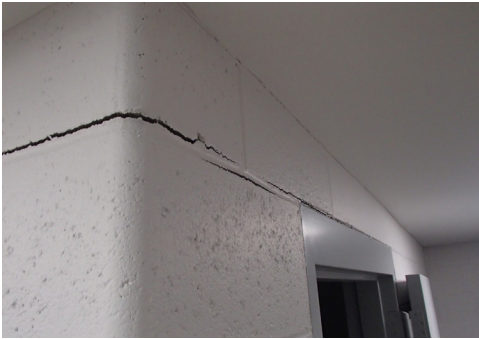
CRACKS IN CMU WALL

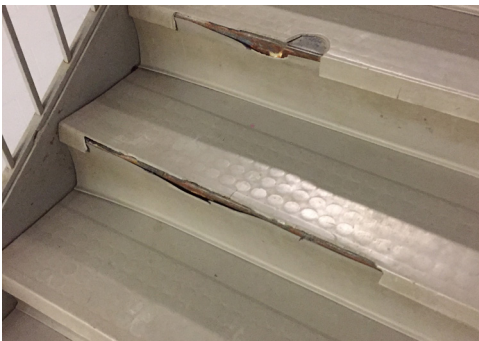
DAMAGED STAIR TREADS

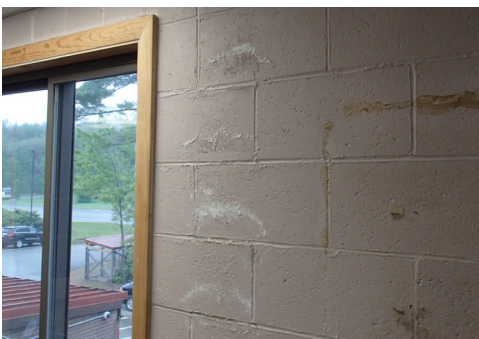
EFFLORESCENCE AT PERIMETER WALLS

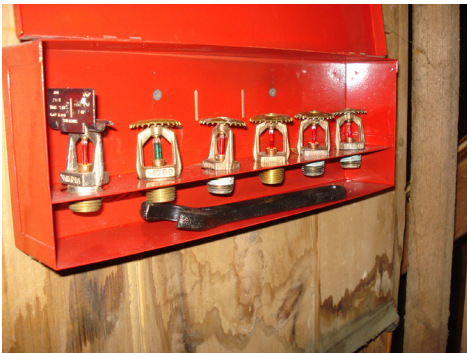
HISTORIC SPRINKLER HEADS

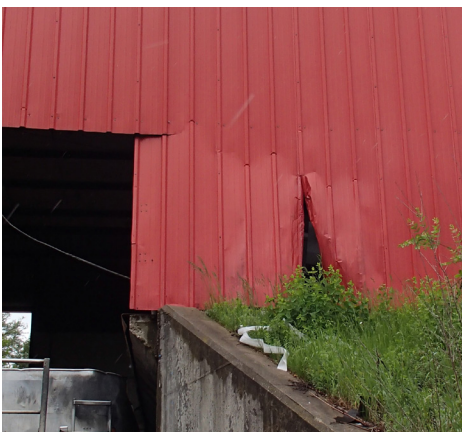
EXTERIOR SIDING DAMAGE

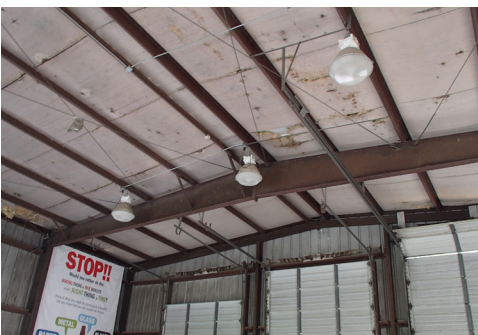
DAMAGED INSULATION AT CEILING
