## TOWN OF BEDFORD

Facilities Masterplan

18 July 2018

# FACILITY ASSESSMENTS

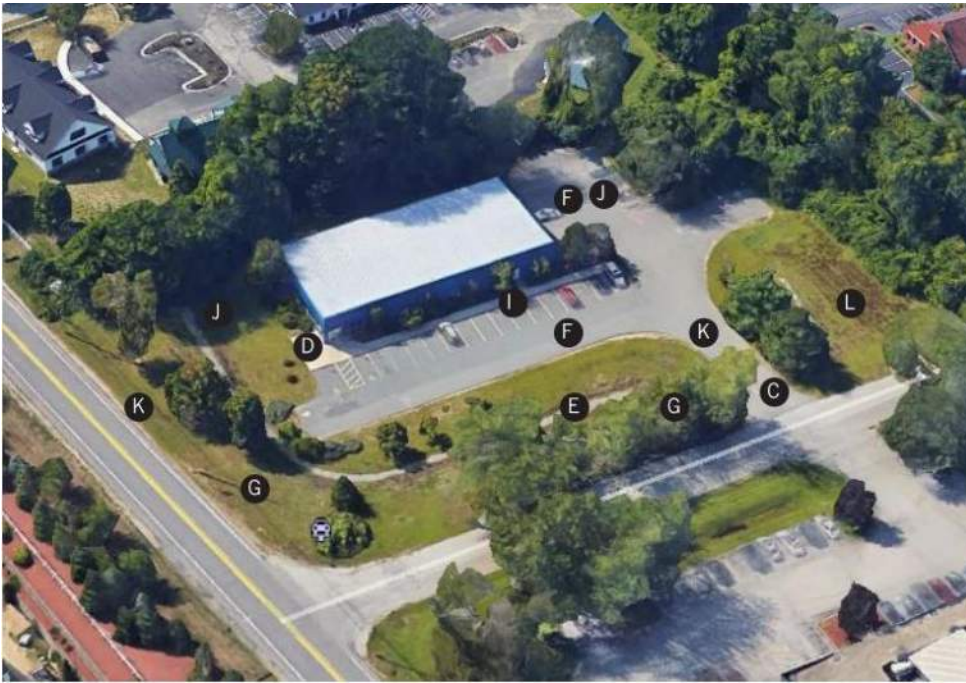
# A. 4 SUNSET LANE

## Observations and Deficiencies Summary

Site access is very good for a potential fire substation although the S. River Rd intersection should be signalized

Utilities include public water and sewer

Recent upgrades include fit up work for the lease use and significant electrical improvements

Pre-manufactured steel structure appears to be in very good condition

Exterior siding and storefront are in good condition

Most/all interior finishes would need to be replaced for a major renovation

It is unclear if the existing building is truly suitable for use as a fire substation

Building is not sprinklered and fire alarm strobes need to be added for better coverage

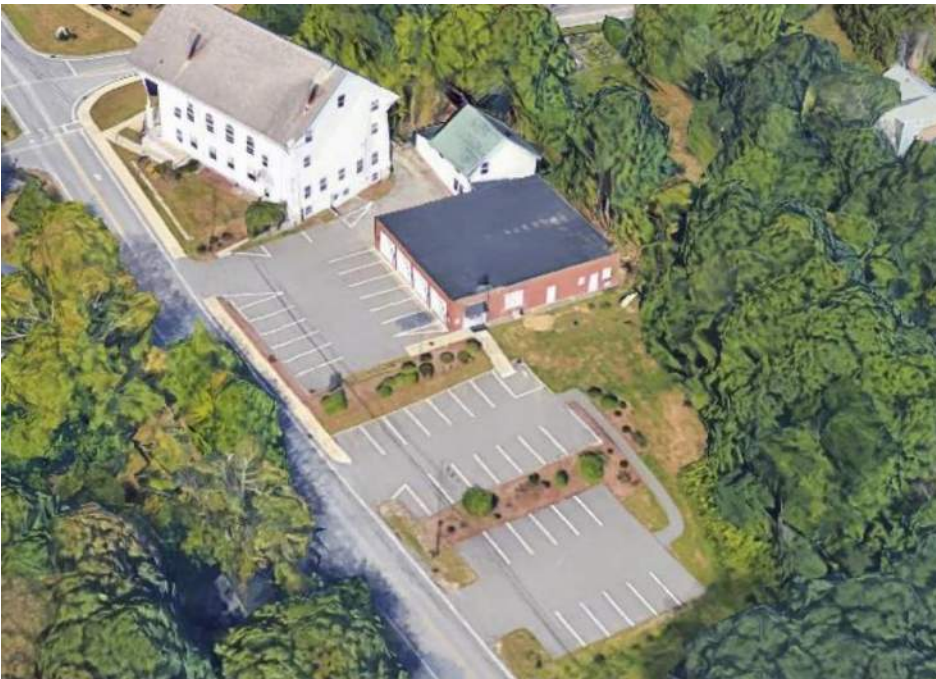
## Observations and Deficiencies Summary

Building is located in the center of the historic village

Limited parking is insufficient for accommodating public meetings and is shared with Town Hall

Recent upgrades include interior finishes in the BCTV building

Annex structure is bowed and requires additional reinforcing

Most interior finishes are in need of repair or replacement

Building is not sprinklered and fire alarm strobes need to be added for better coverage

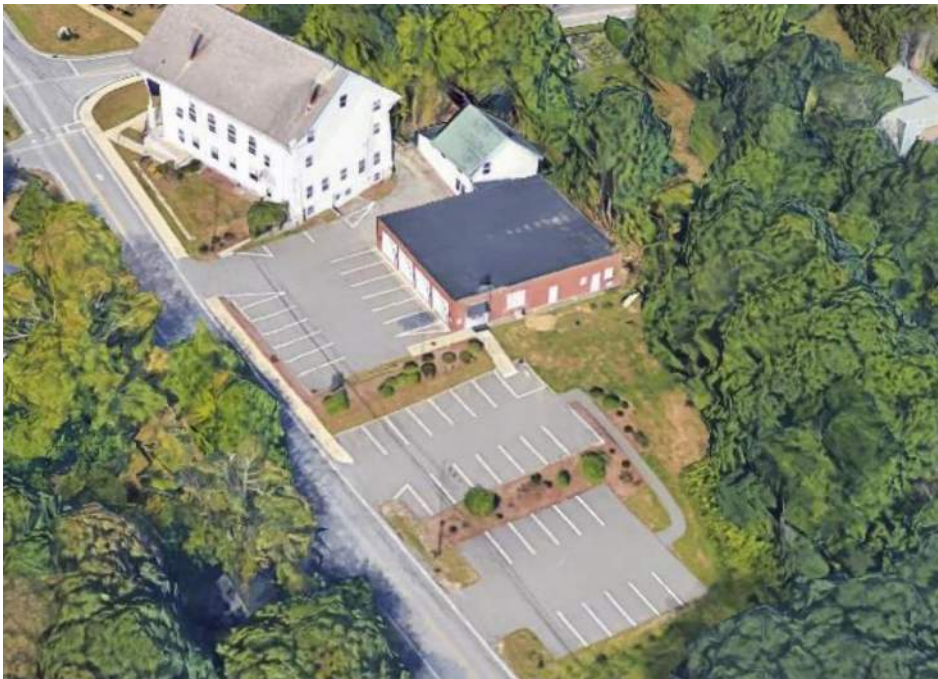
Recent upgrades include steel reinforcement to the Annex building

Wood structure is bowed and requires additional reinforcing

Exterior shows minor signs of rot and windows should be re-glazed or replaced; siding and roof are in good condition

Interior is not finished in most areas

Interior accessibility improvements are needed for ADA compliance including an stair and possible lift if second floor becomes occupied

Building is not sprinklered and fire alarm system needs to be improved

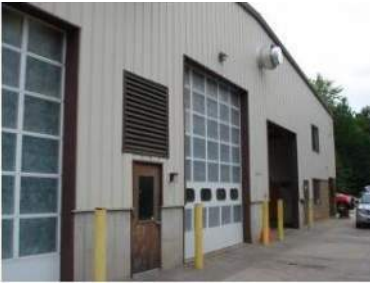
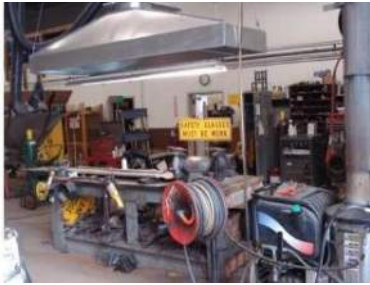
# C. HIGHWAY GARAGE

Site access and circulation is good for fleet

Improve visitor and staff parking / circulation

Recent upgrades include roof repairs and new carbon monoxide exhaust system

Pre-manufactured steel structure appears to be in good condition

Exterior siding, doors, and canopies are generally in need of repair

Most interior finishes are in need of repair or replacement

Interior accessibility improvements are needed for ADA compliance including an enclosed second stair and elevator or lift

Building is not sprinklered and fire alarm strobes need to be added for better coverage

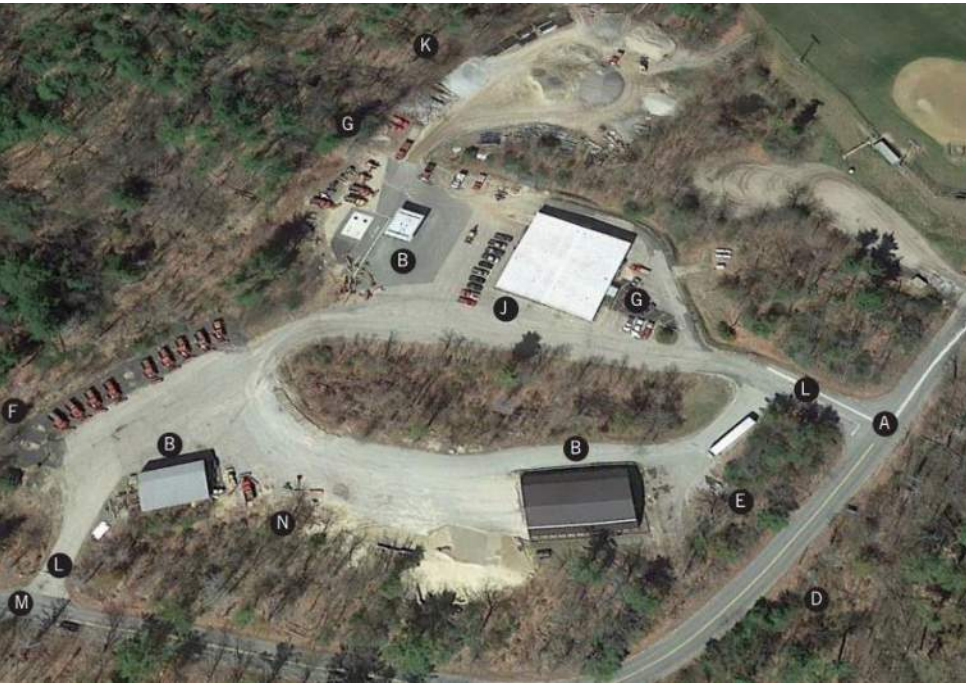
## Observations and Deficiencies Summary

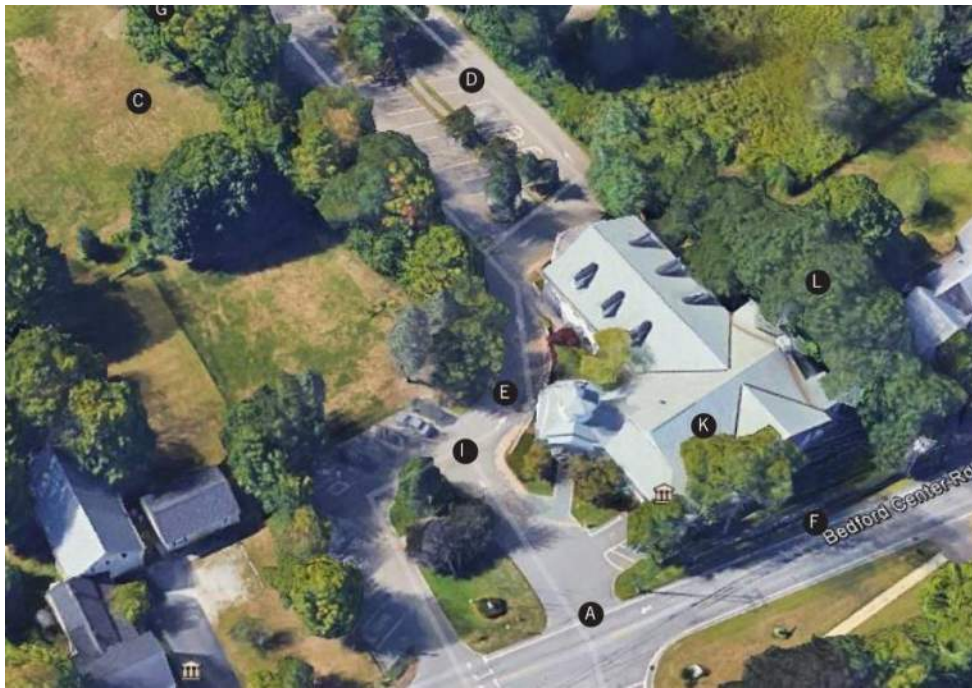
## Observations and Deficiencies Summary

Site access and circulation is tight, book return creates a choke point at entry

Proposed parking expansion will be an improvement

Recent upgrades include geothermal system

Visible structure appears to be in good condition

Exterior veneer, siding, doors, and canopies are well maintained and are generally in good condition

Most interior finishes are in fair to good condition but are heavily used and require replacement in some areas

Interior accessibility is good although communicating stair is narrow

Drainage from lower level plumbing to septic is a problem but most systems are in good condition

Building is fully sprinklered and fire alarm system appears to meet requirements

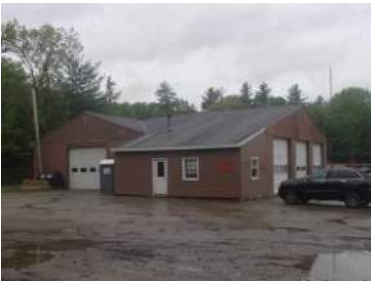
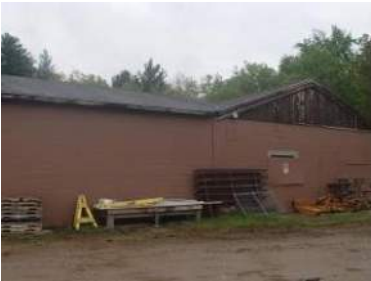
# E. NASHUA ROAD FACILITY

Site access is convenient to service and access central Bedford facilities but is remote from the Highway Garage

Awkward adjacency to parking for fields

Recent upgrades include site improvements

Wood structure appears to be in fair condition and cracking was observed in several locations of the CMU exterior walls

Exterior siding, doors, and canopies are generally in need of repair

Most interior finishes have not been maintained due to the unoccupied storage use of the facility

There is a portable toilet outside the building, there is no working indoor toilet.

Building is not sprinklered and does not have a fire alarm system

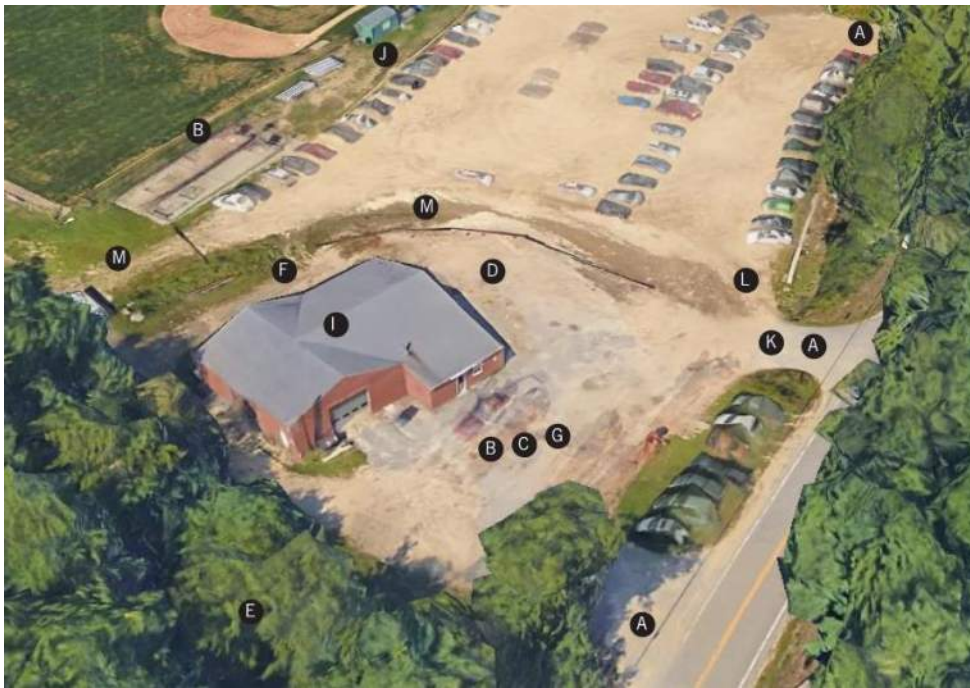
## Observations and Deficiencies Summary

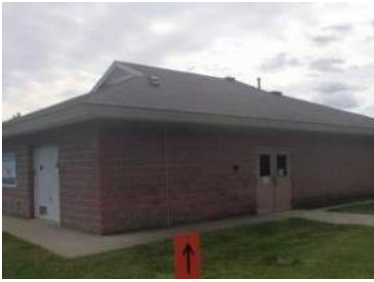
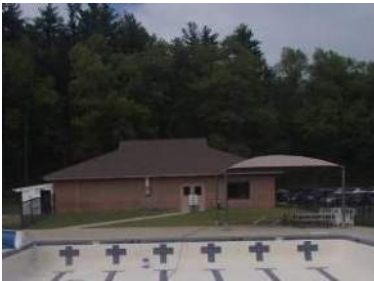
# F. POOL FACILITY

Site access and parking are adequate

Recent upgrades include improvements to the mechanical system which is in good condition and LED lighting in the parking lot

Visible structure appeared to be in fair to good condition and minor cracks were observed in the CMU exterior walls

Exterior siding, doors, and trim is in need of repair and/or repainting

Interior finishes are in good condition but flooring is very worn and service areas are mostly unfinished

Interior accessibility is good but there are missing ADA compliance items in a few locations

Building is not sprinklered and fire alarm system appears to be adequate

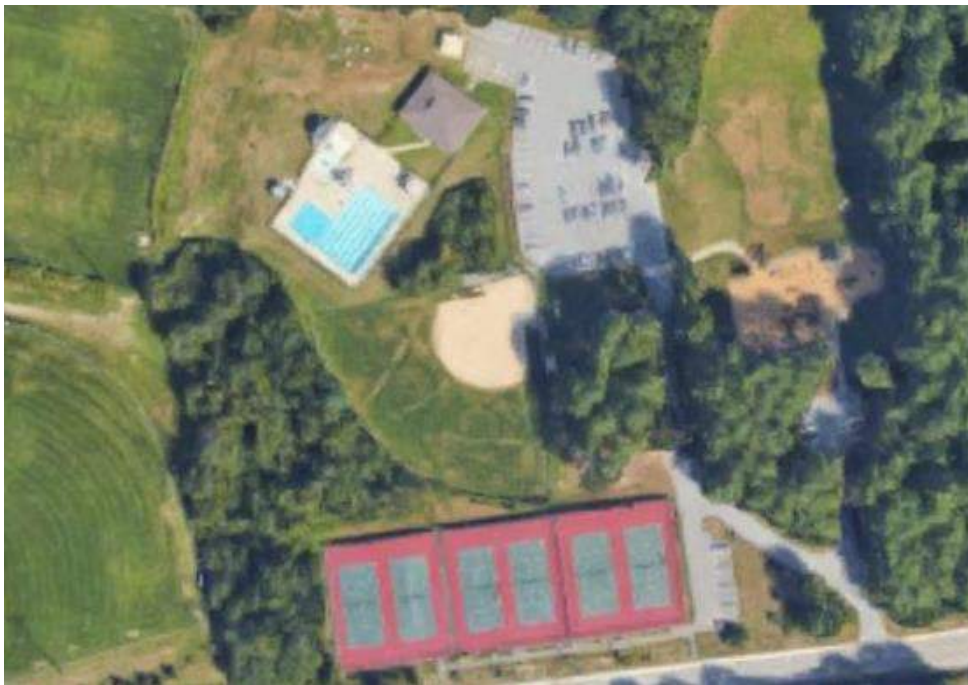
## Observations and Deficiencies Summary

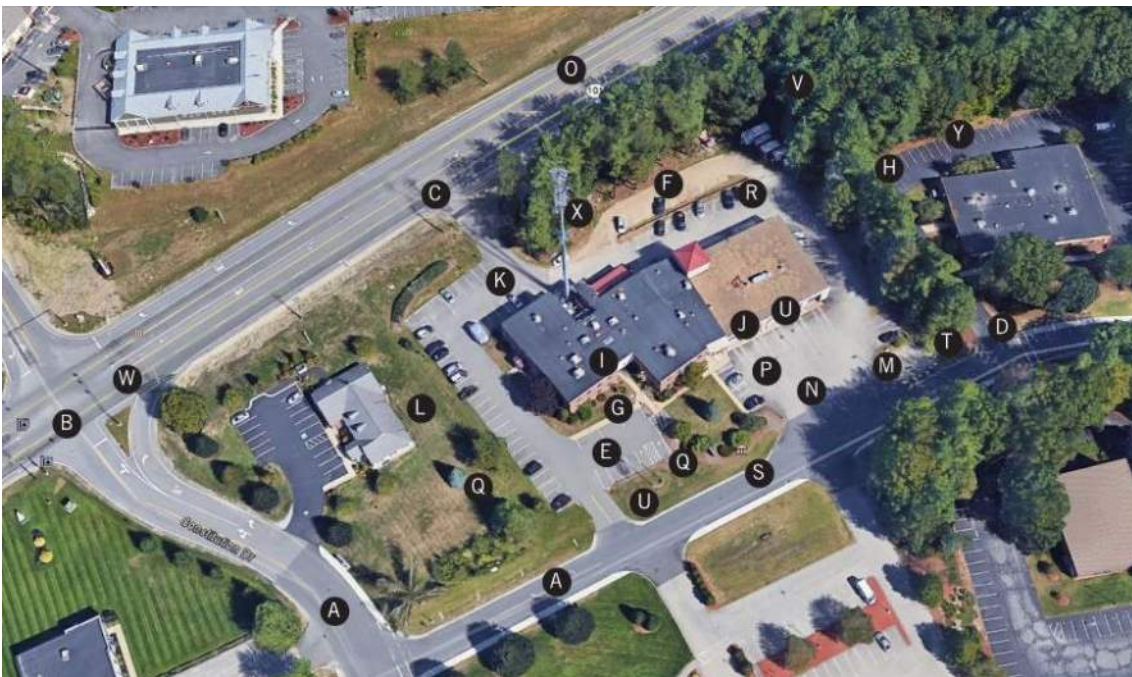
Observations and Deficiencies Summary

Site access and congested circulation are not suited for a public safety building

Secure separation of visitor and fleet vehicles is needed

Recent upgrades include roof repairs, electrical service entrance, and LED lighting

Structural steel appears to be in good condition but some corrosion was observed in the apparatus bay

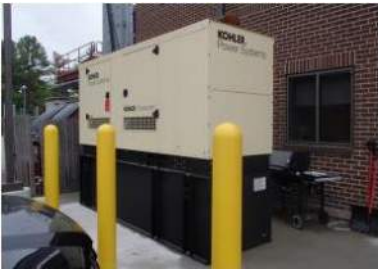
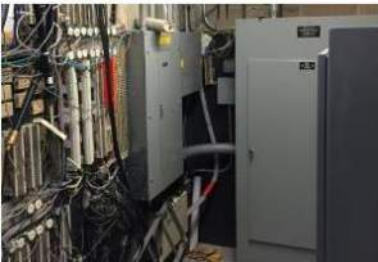
Exterior envelope in original building is in good condition but new CMU envelope does not provide appropriate thermal and moisture barriers

Most interior finishes are typically in need of repair or replacement

Interior accessibility improvements are needed for ADA compliance including improved stair, elevator, and door approach clearances

Building is sprinklered but fire alarm system requires improvement

Improvements needed for HVAC throughout including HEPA filtration in police area and improved ventilation throughout building

Electrical and communications systems are not secured or properly separated and should be improved

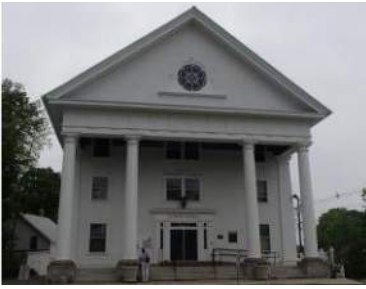
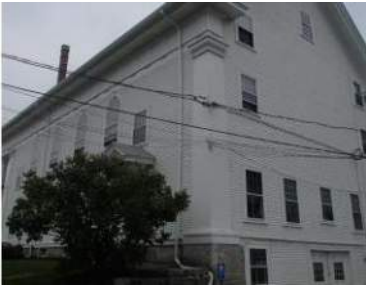
# I. TOWN HALL

Exterior elements are in good condition for their age

Most interior finishes are in fair condition but there are many areas in need of repair or replacement from wear or water damage

Interior accessibility improvements throughout are needed for ADA compliance

Building is sprinklered and fire alarm strobes and emergency lighting need to be added for better coverage

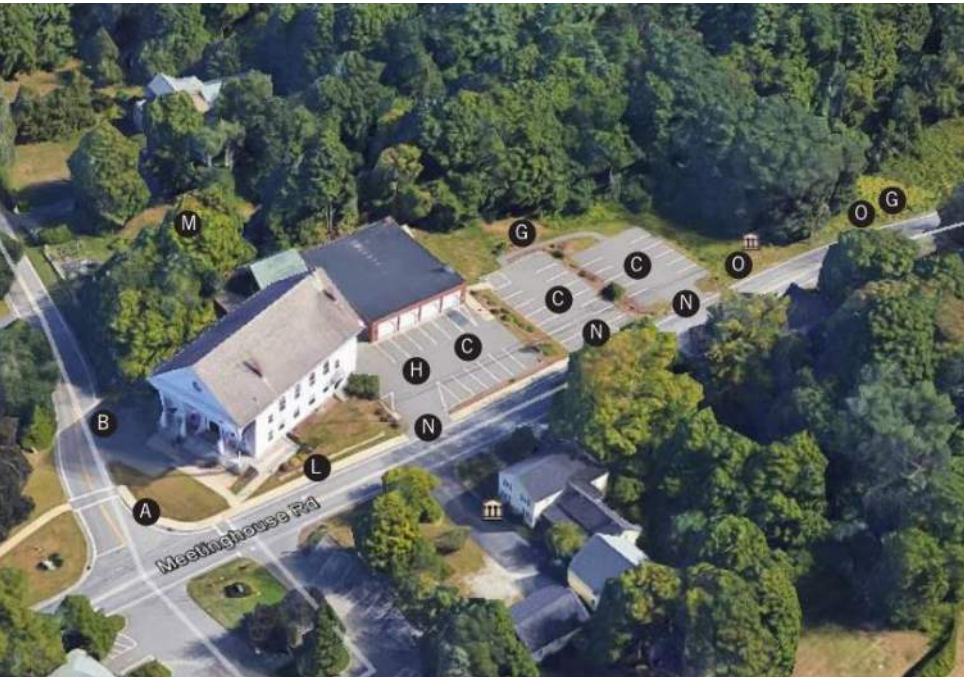
## Observations and Deficiencies Summary

Building is on the National Register of Historic Places

Limited parking is insufficient for accommodating public events and is shared with BCTV

Visible structure was limited to basement lally columns supporting the first floor framing

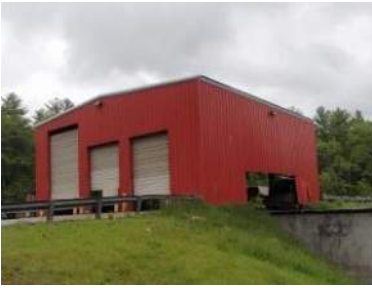
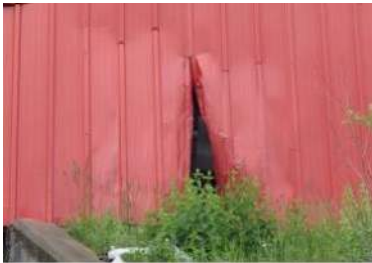
# K. TRANSFER STATION

No issues in the pre-manufactured steel structure were observed

Exterior metal siding and doors are generally in need of repair

Most interior finishes, which are limited, are in need of repair or replacement

Building is not sprinklered and fire alarm systems appear to meet code requirements

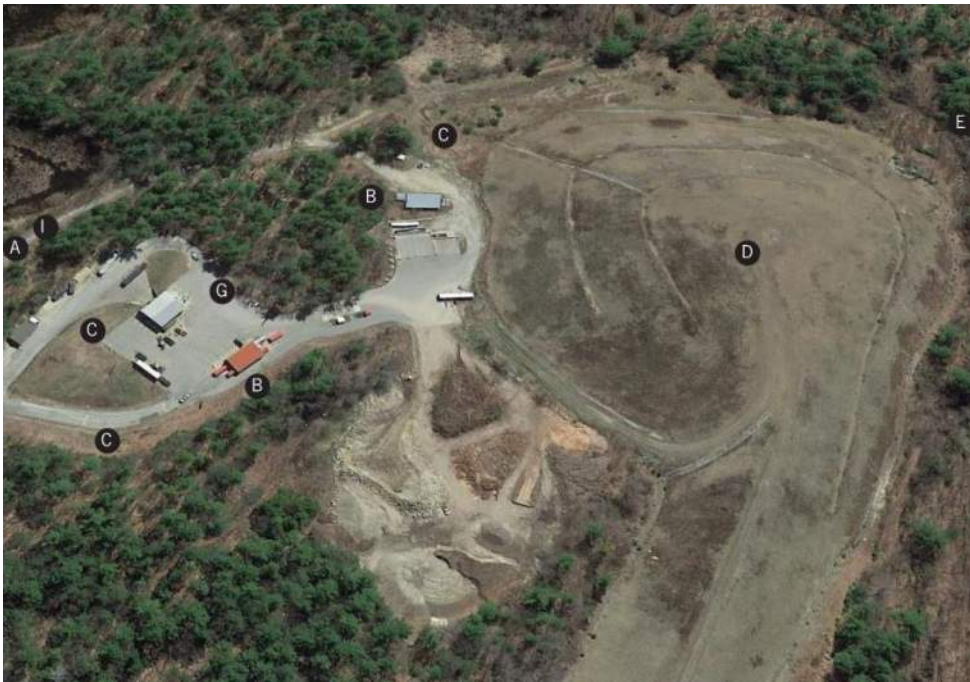
## Observations and Deficiencies Summary

Site access and circulation is constrained and congested

Safety issues between visitors and large dumpster transport trucks occur during high use times, weekly

Interior accessibility improvements are needed for ADA compliance for staff and visitors

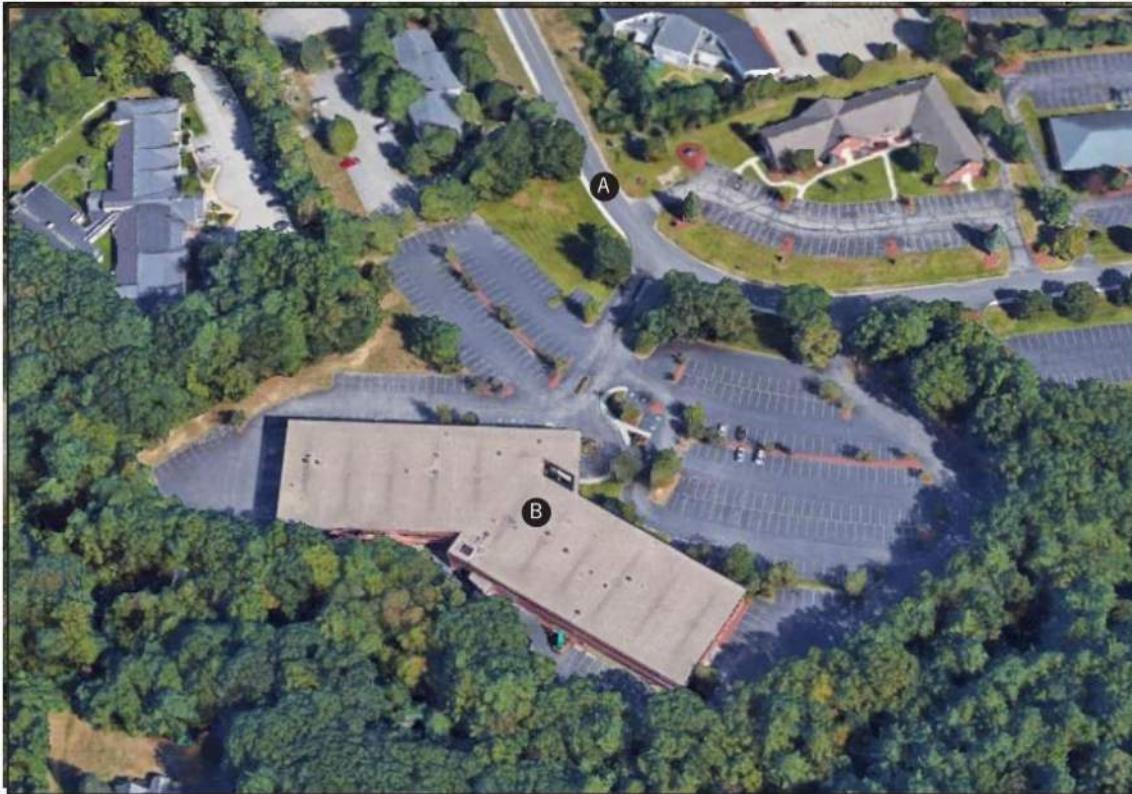
**Observations Summary**

Reviewed for consideration as a single municipal facility to replace Town Office, Police Department, and potentially BCTV and Library

Police Department is incompatible as an integrated part of a combined facility and existing building is much larger than the Town needs

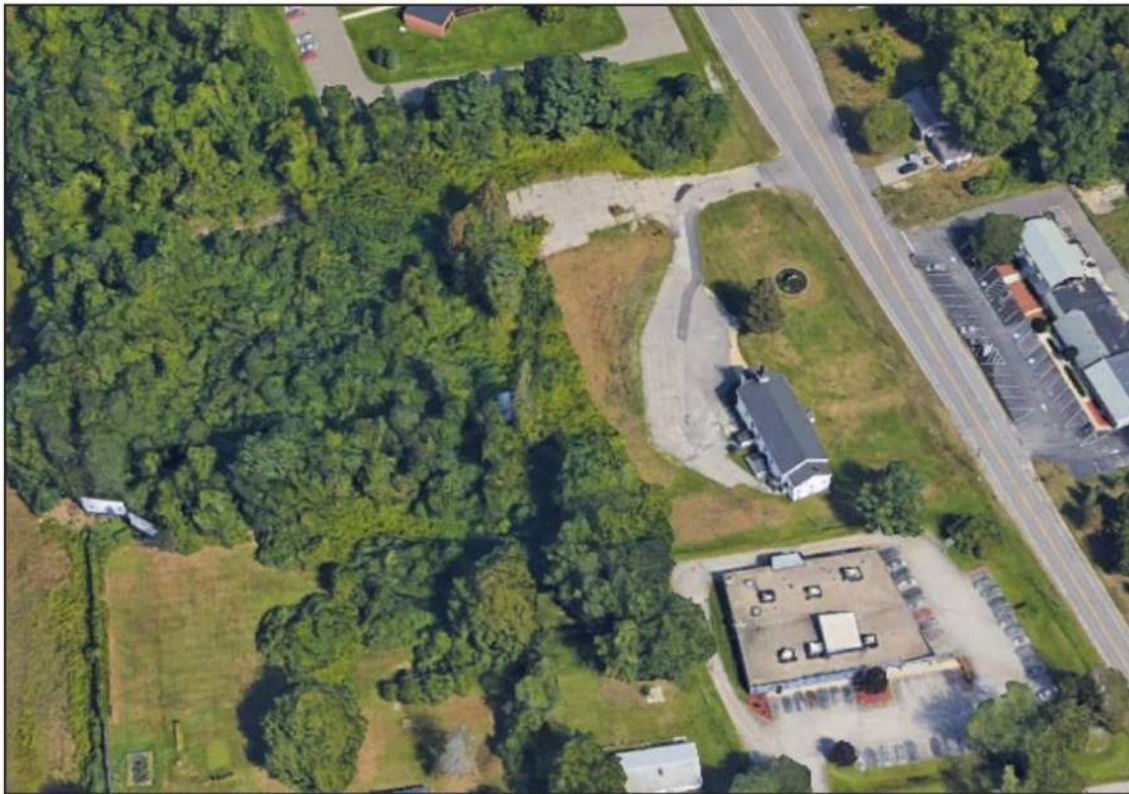
**Observations Summary**

Reviewed for consideration as an alternative location for fire substation or combined substation and police department

Location is very remote to provide service needed from the Police Department

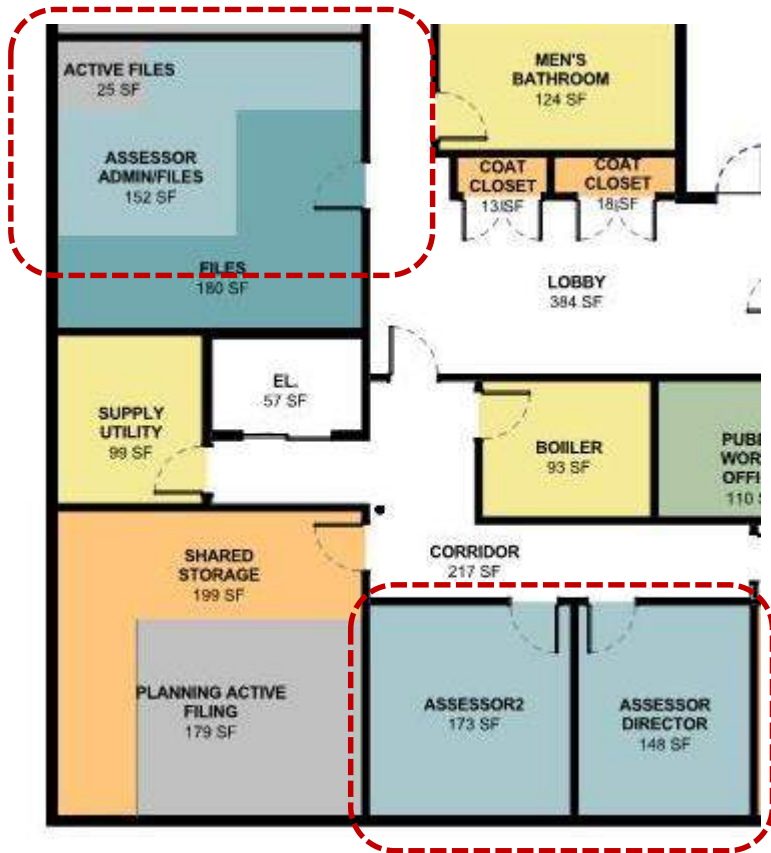
A1. Town Office – Lower Level Detail Plan

- Space deficiencies result from existing shared work and office areas that should be separated
- Large meeting room layout and seating capacity is low due to repurposed space
- Overall, most spaces work well for the BCTV need

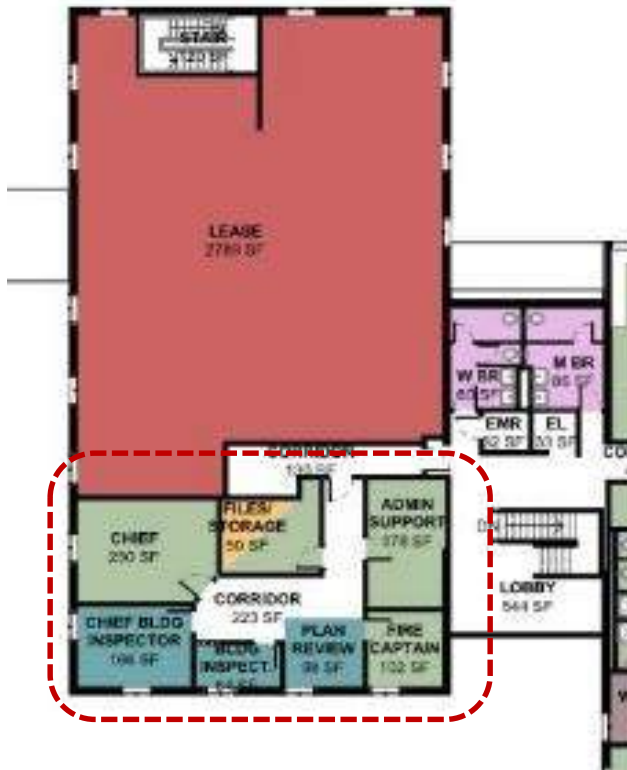
C1. Safety Building-Upper Level

Space deficiencies result from an existing single shared work and office area that should be separated and/or better arranged

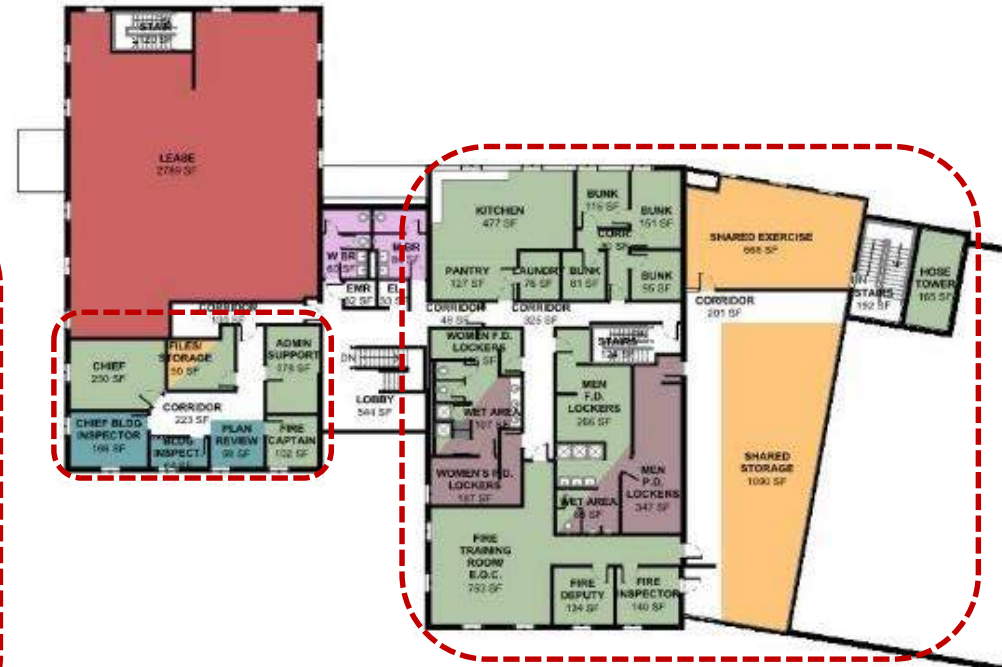
G1. Public Safety Building-Upper Level

Space deficiencies result from existing shared work and office areas that should be separated from Police and Building Department

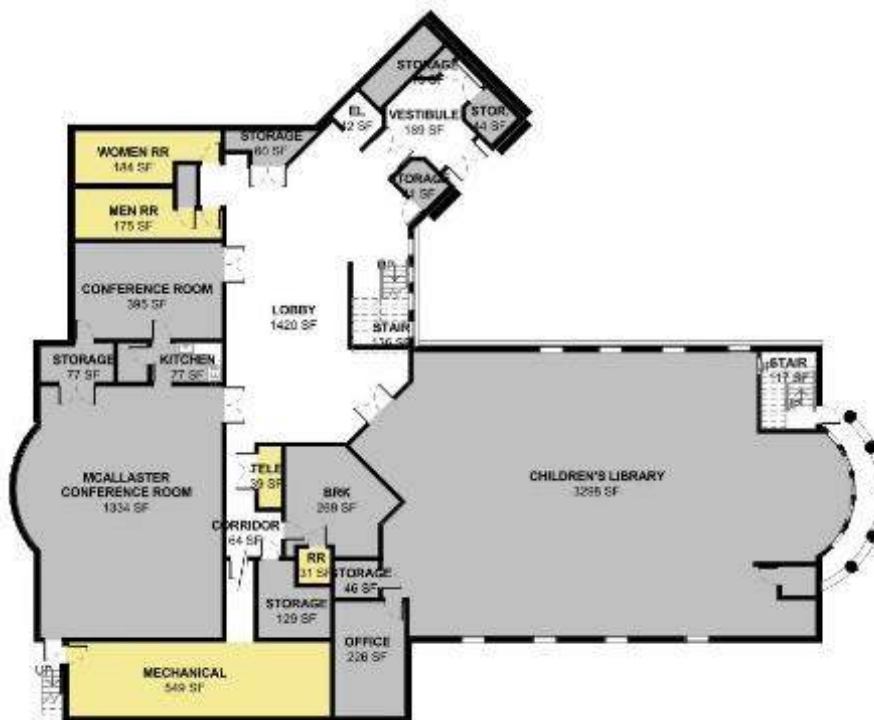
I. Library- Lower Level

Town holds all volumes in circulation resulting in tall stacks throughout and prefers enough space to lower stack heights

Option to separate access to public rooms from library program areas is needed for better off hours use of the building

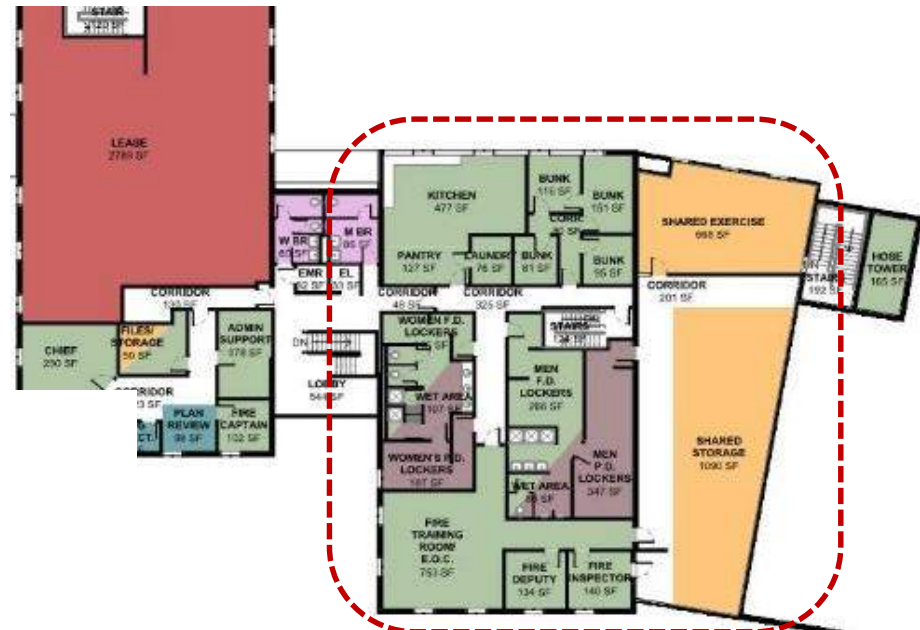
G1. Public Safety Building-Upper Level

Space deficiencies exist in all police divisions including fleet
