# TOWN OF BEDFORD

Municipal Facilities Master Plan and Space Needs Assessment

Volume One: Space Program, Existing Facility Assessments and  
Space Utilization Analysis Draft

August 03, 2017

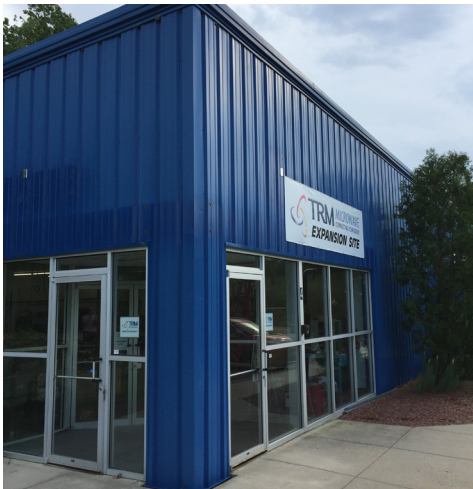
BUILDING EXTERIOR / MAIN ENTRY

- Building Envelope**
- Building cladding is corrugated metal siding and is in good condition aside from a few locations of minor damage and denting.

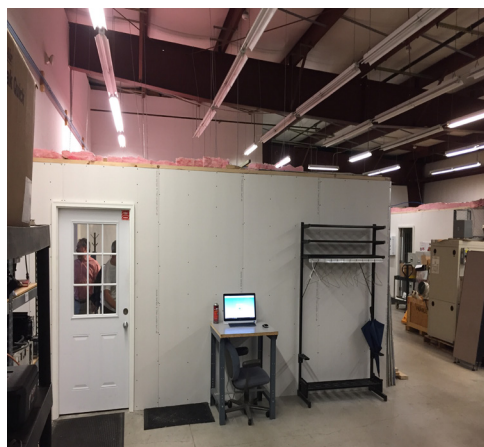
BUILDING INTERIOR

- Building Interior**
- The building interior has been recently fit up to accommodate its current use. Most finishes are in good condition however assemblies such as ceilings had exposed batt insulation at the top edge and other elements indicating short-term construction solutions.

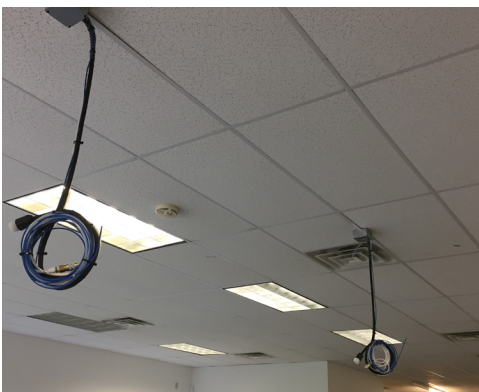
CORDS HANGING FROM CEILING

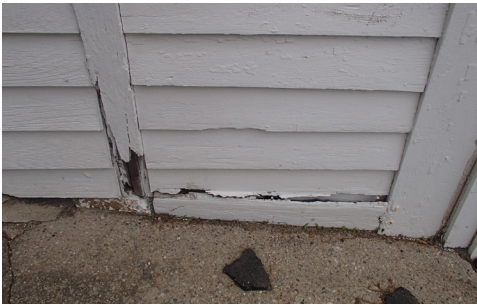
- Building Envelope**
  - Foundation does not appear original, but is in good condition.
  - Windows need to be re-glazed.
  - Overhangs are in need of paint.
  - Some rot of wood siding is observed at grade.
  - Door on second floor in exterior wall with no stair or landing beyond is a safety hazard.
  - Exterior doors show signs of corrosion.

DAMAGE AT WOOD SIDING AND TRIM

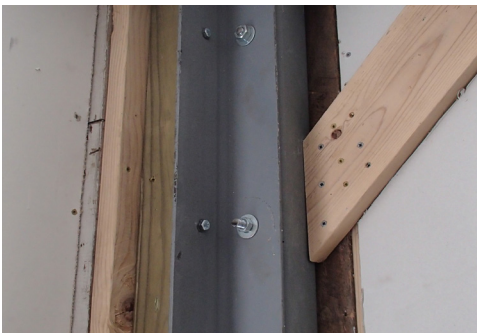
- Structural**
  - The north wall is observed to be bowing out at the second level – above what appears to be a steel tie rod.
  - Evidence of steel reinforcement to south wall is observed.
  - Signs of reinforcement to roof from interior are visible, but only in part as interior of second floor ceiling is clad in new GWB.

STRUCTURAL REINFOR CONCRETES AT SOUTH WALL

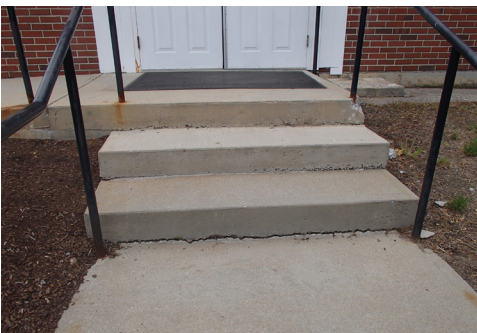
- Site**
  - Minor cracking and separation of concrete stair from walkway observed at entry door.
  - Ramp does not meet ADA requirements for railing.
- Structural**

- Brick veneer appears in good condition overall. Minor discoloration and residue from past attachments to façade observed throughout.
  - Some corrosion is observed at main entry door frame.

CRACK IN CONCRETE STAIR CORROSION AT DOOR FRAME

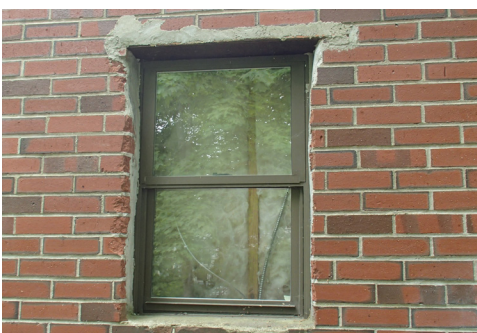
- No significant structural issues were observed for this facility.
- Building Envelope**
  - North wall of building has single window installed in roughly cut opening. Walled over at interior. Wood stud and insulation visible from exterior.

WINDOW COVERED FROM INTERIOR

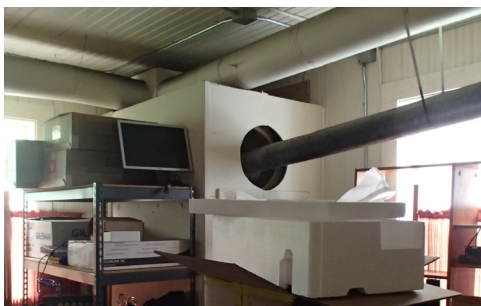
BOILER IN CLOSET WITH EXPOSED EXHAUST VENT

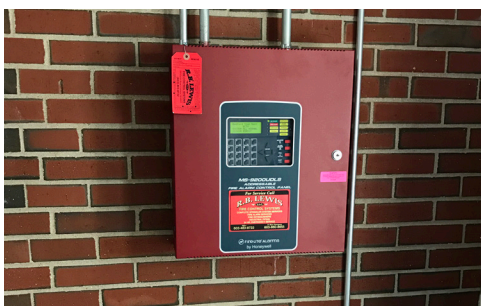
LIFE SAFETY

The building does not have a sprinkler system although other life safety systems were observed to be in place. The fire alarm system serves the Annex and the Old Town Hall. Strobe coverage is lacking. Pullstations are mounted at 54" which is above the ADA height of 48". The exit signage appears adequate with the exception of the main hall. The emergency lighting is newer LED type integrated with the exit signs.

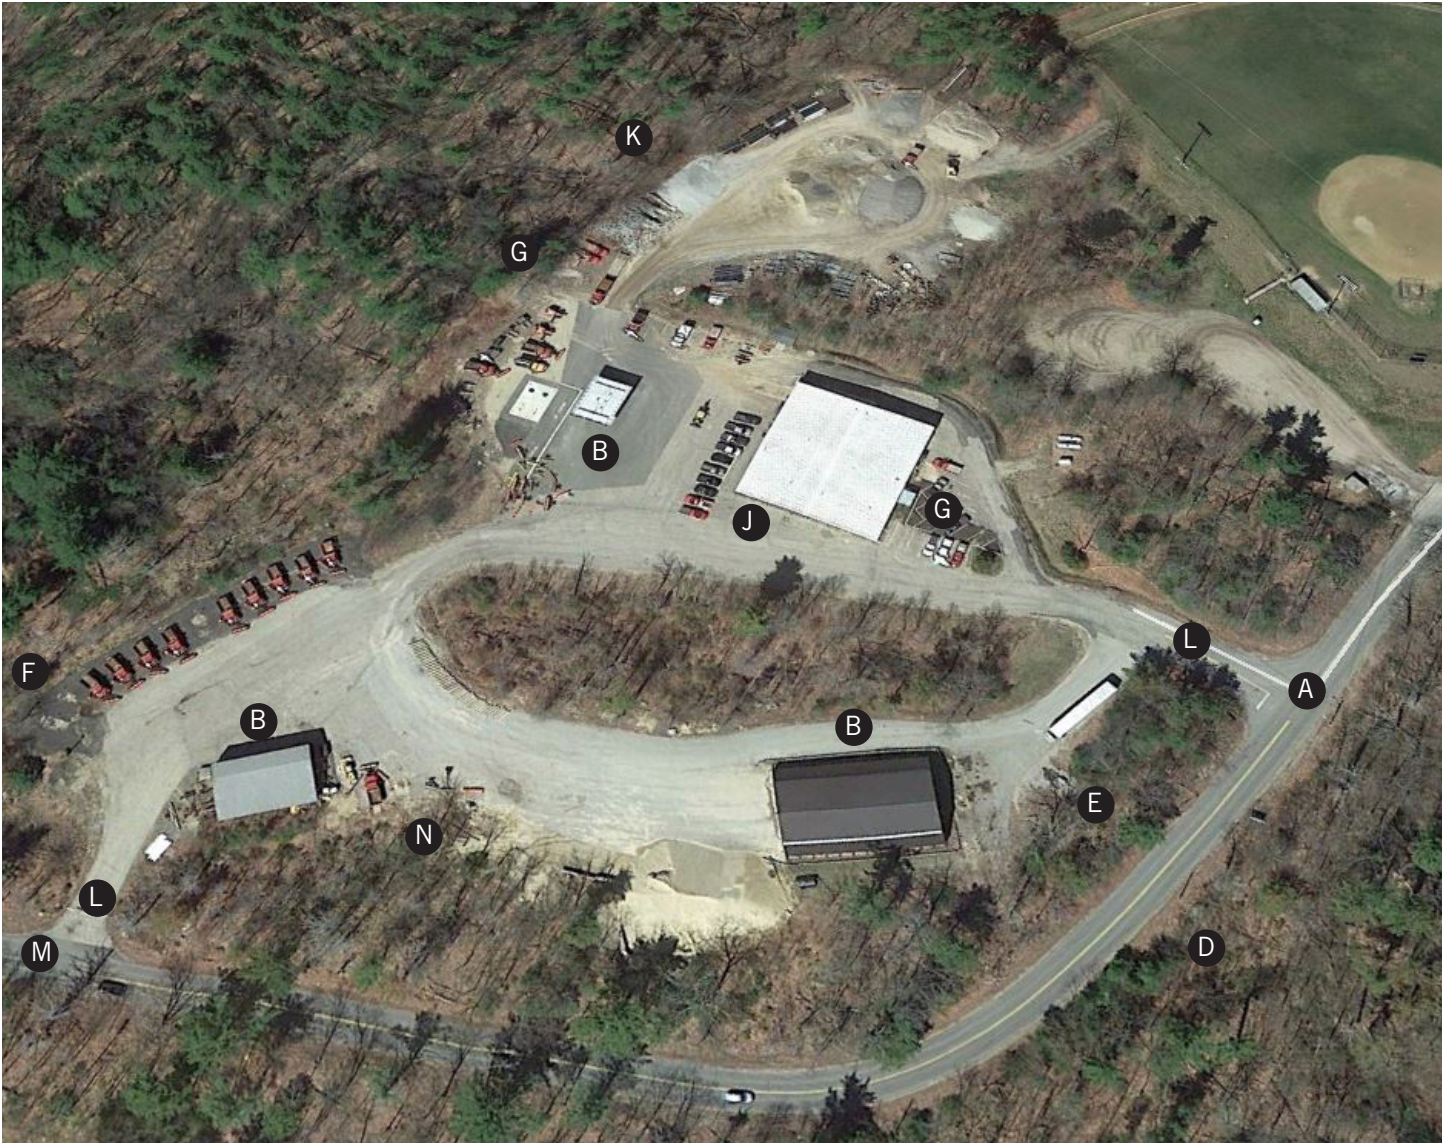
Key Noted Site Plan: See 'Site Issues, Needs, and Observations'

- Site Features and Improvements**
  - G. Pavements: Pavements have been upgraded in areas, patched in others and generally appears to be in fair to poor condition.
  - H. The area around the front entrance could be enhanced to delineate public parking and reinforce the main entrance.

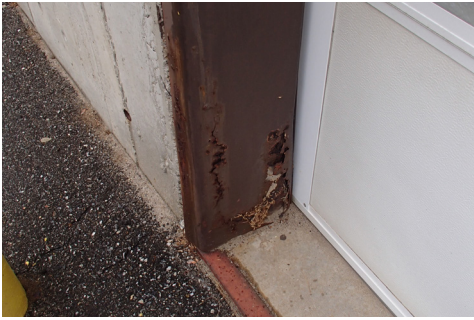
CORROSION AT DOOR FRAMES

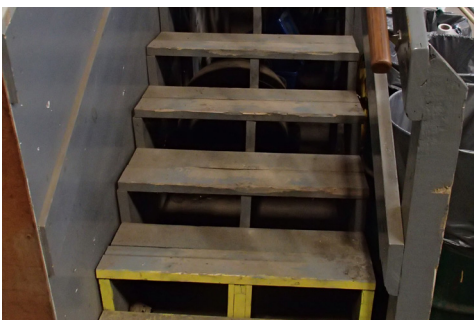
OPEN STAIR TREADS  
MISSING RAILING

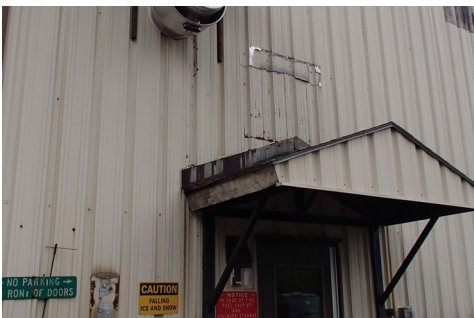
- Building Envelope**
  - Metal siding stained and damaged near garage entries from vehicular collisions. Trim is loose or damaged in several locations. Various patches in metal siding observe around building exterior. Significant staining at grade on CMU walls from water/soil exposure.
  - Canopies and overhangs are weather damaged and in need of repair.
  - Exterior metal doors and frames show signs of corrosion. Several garage doors are punctured/dented.
  - Recent upgrades and repairs to the roof were noted.

PATCHING AND CORROSION AT SIDING

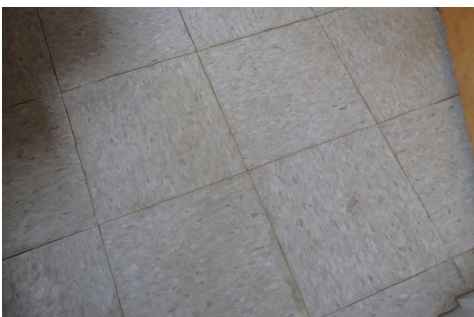
- Building Interior**
  - Flooring and ceilings are worn and in need of replacement. VCT shows signs of water infiltration at joints on first floor; cracked and discolored on second floor.
  - Second floor has painted and unpainted plywood floors in some locations. Where carpeted, carpet is stained and in need of replacement.
  - Walls and doors are in need of repainting.
  - ACT ceiling throughout is mismatched, damaged and in need of repair at many locations.
  - Wooden stair from garage to level 2 has open treads and railing on one side only.
  - Water infiltration is evident at interior GWB walls and ACT ceilings at east corner of building and under west corner garage door.
  - FRP wall panels and floor tile in restrooms heavily worn.

WATER INFILTRATION AT VCT

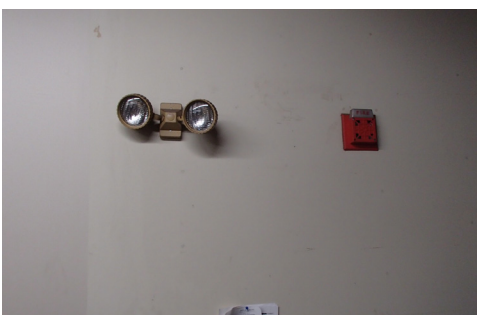
Aside from not being sprinklered, the building has older life safety elements such as emergency lighting, fire alarm control panel, horn strobes, exit signs, pull stations, and heat detectors. Upgrades to these systems is recommended as noted in the 2012 facilities report as well as improvements in exit signage.

LIFE SAFETY

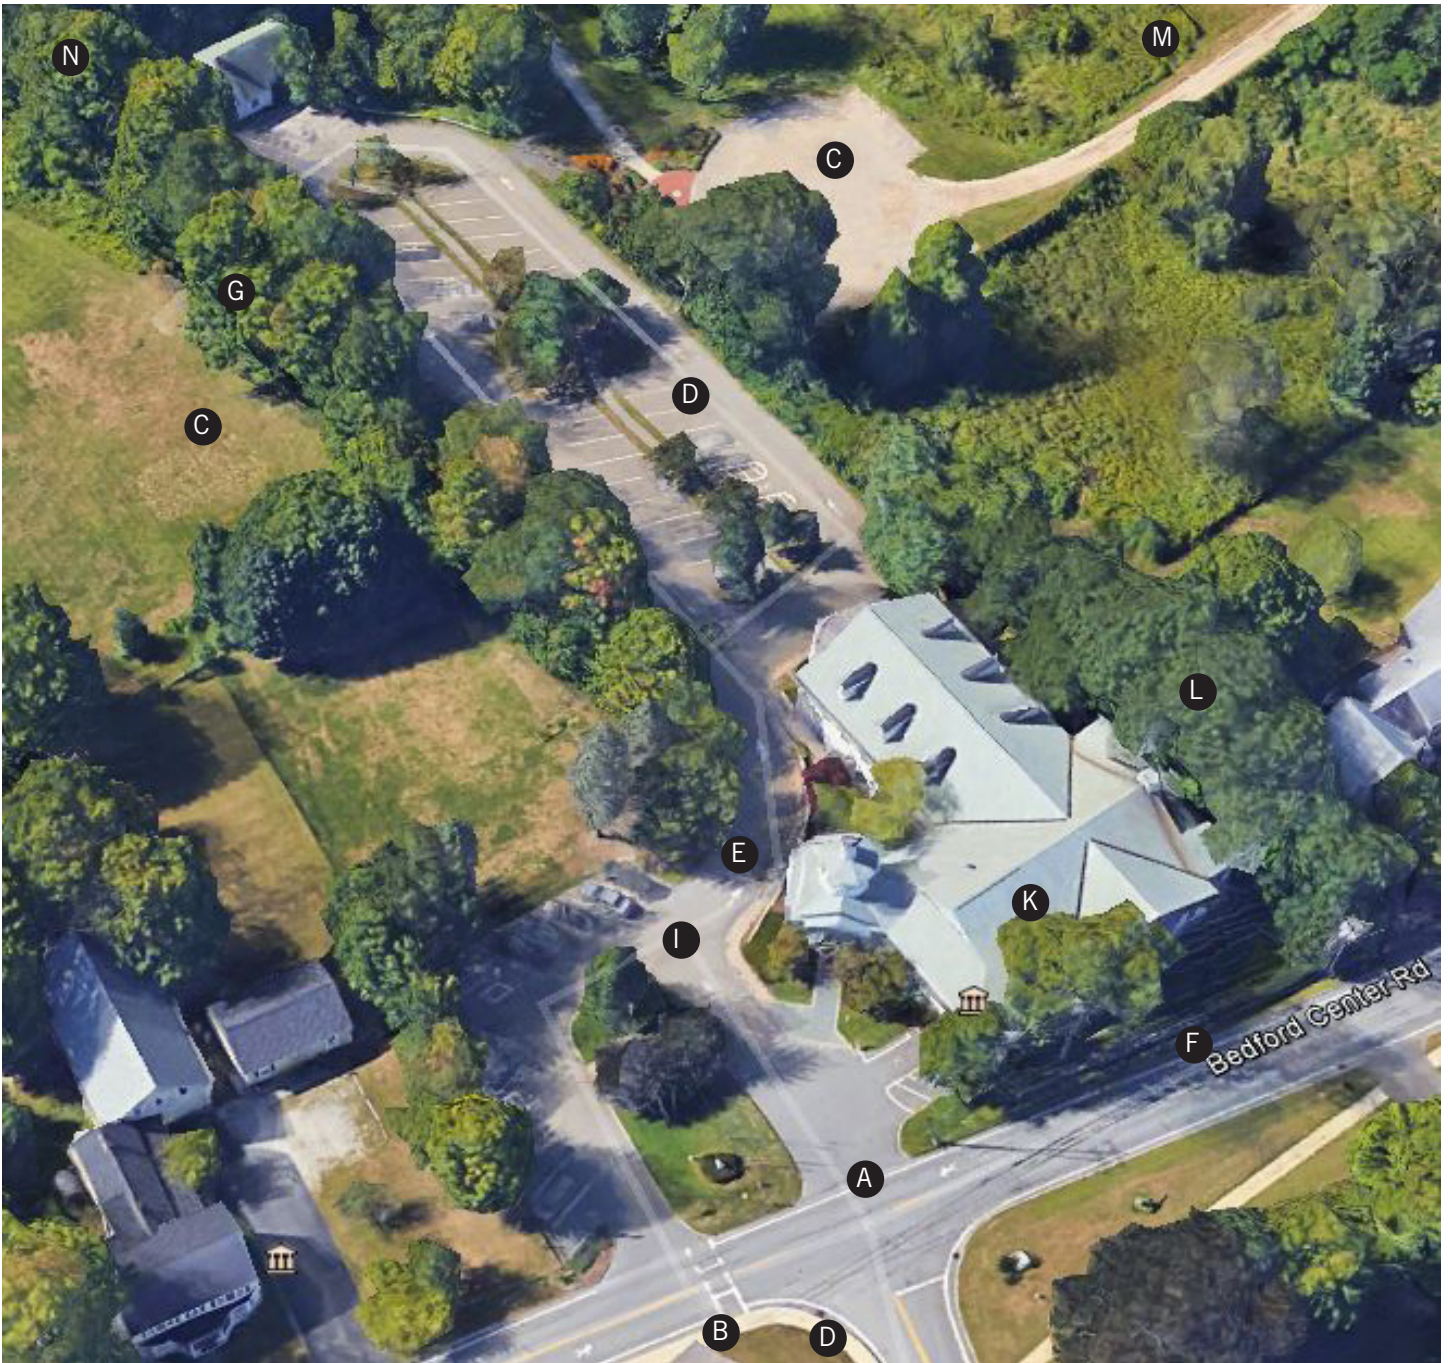
Key Noted Site Plan: See 'Site Issues, Needs, and Observations'

- Site Features and Improvements**
- I. Pavements: The parking lots appear to be in good condition. Sidewalk pavers are damaged and are being replaced with brick.

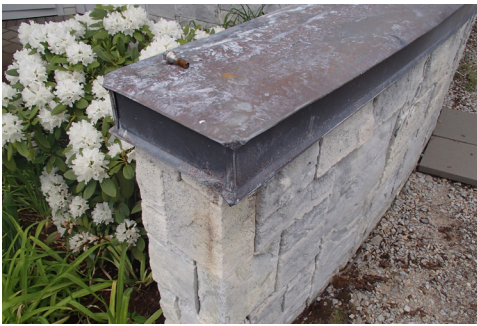
- Building Envelope**
  - Cultured stone veneer shows some discoloration and wear throughout. Heavily stained at areas of water runoff from roof.
  - Metal flashings and trim near grade are dented and discolored.

DAMAGE AT METAL FLASHING AND CAPS

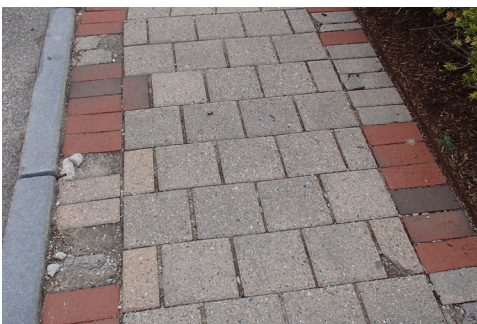
- Site**
  - Pavers in site walkways show extensive signs of damage and many have been replaced with red brick
- Structural**
  - To clarify concern about floor framing strength, original shop drawings were reviewed. First floor framing was confirmed to be 150 pounds/square foot.

DAMAGED PAVERS WITH BRICK REPLACEMENTS

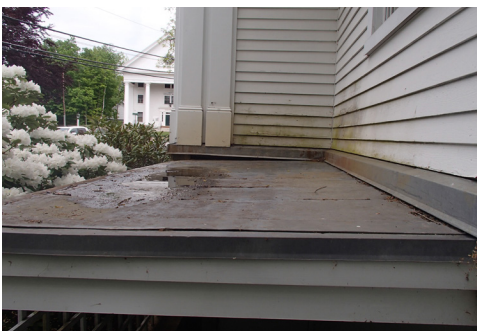
- Generally wood siding is in good condition, but several areas of peeling paint were observed.
  - Significant water damage to siding was noted in the northwest corner building over egress stair roof. Standing puddles of water observed on roof.

Significant water damage to siding and staining of cultured stone was noted as a result of roof water runoff. Evidence of water infiltration was observed in the area of the exit stair discharge. Recent improvements to rainwater management such as gutters, downspouts, and catch basins were noted.

Standing puddles of water observed at a small flat roof canopy however the asphalt shingle roof appeared in good condition.

WATER DAMAGE AT SIDING POOLING IN ROOF

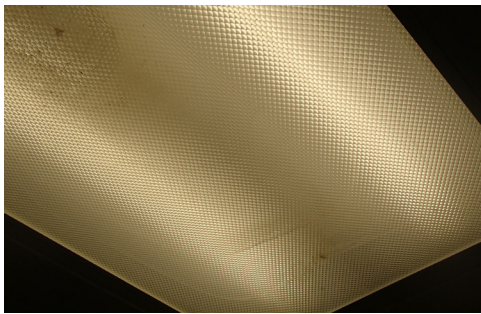
ELECTRIC LIGHTING WITH WATER POOLING

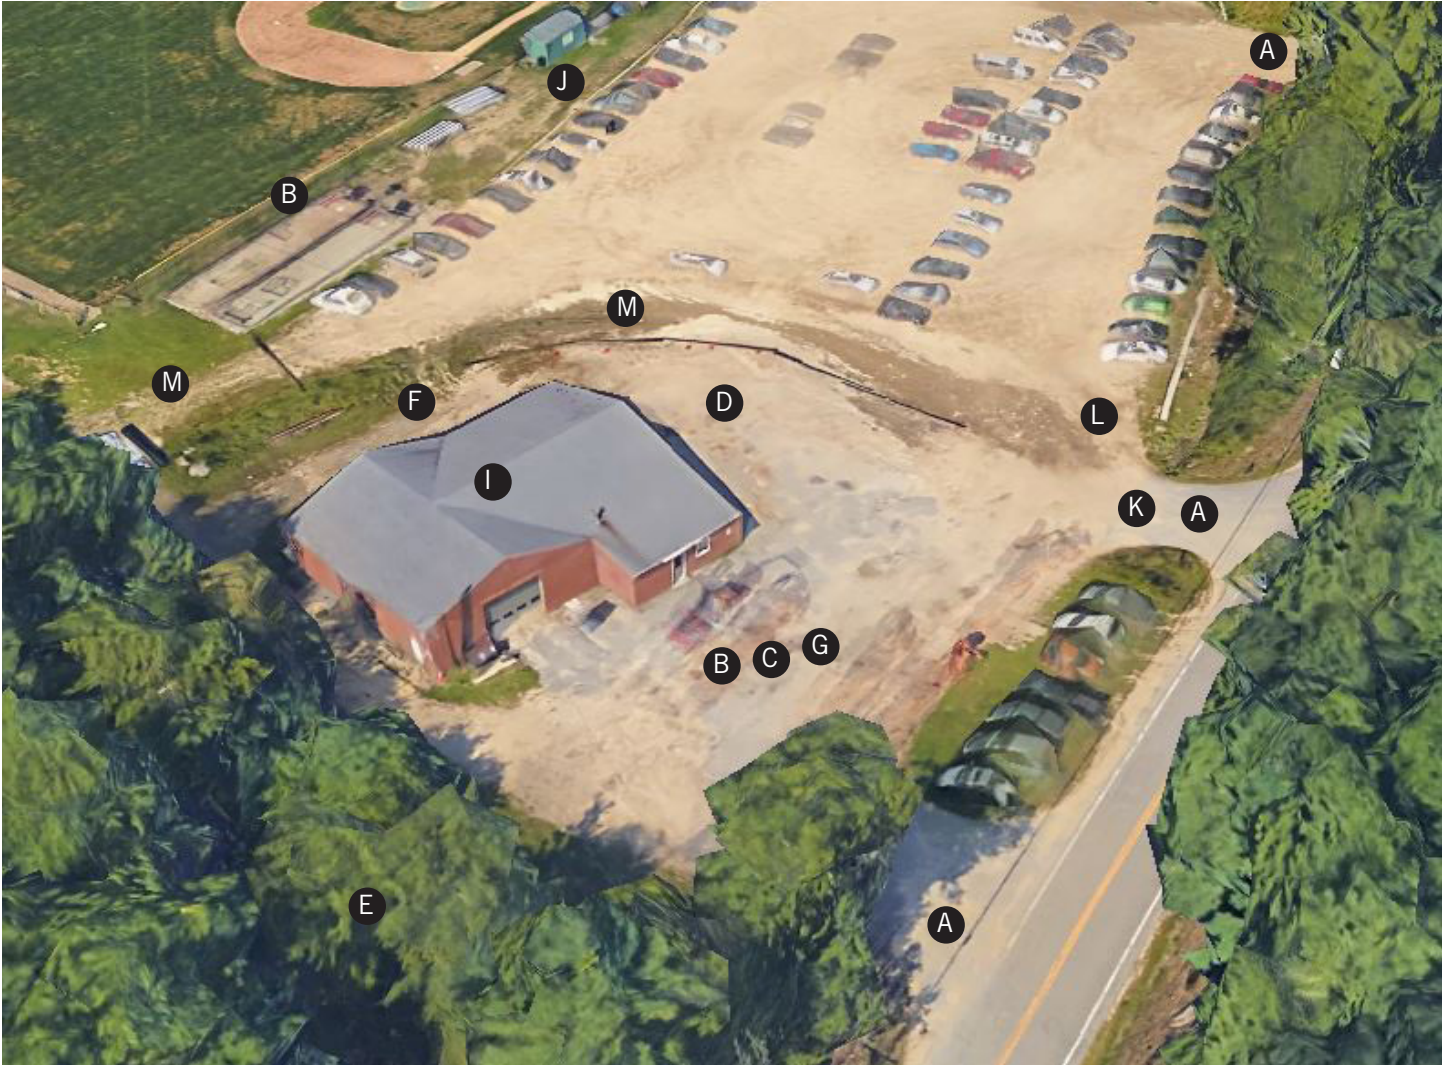
Key Noted Site Plan: See 'Site Issues, Needs, and Observations'

- Site Features and Improvements**
  - G. Pavements that remain have been generally covered by gravel and remnants appears to be in poor condition.

- Opportunities and Constraints**
  - K. Access and Context – The site has direct access and egress to Nashua Rd.
  - L. Interior vehicular circulation between the building parking area and the ball field parking lot to the north and west, if desired, should be moved away from the existing building parking lot driveway entrance at Nashua Rd.
  - M. Future Expansion on-site – The site is limited by the ball fields/ capped landfill to the north and west. Existing foundation condition at the building site should be determined.

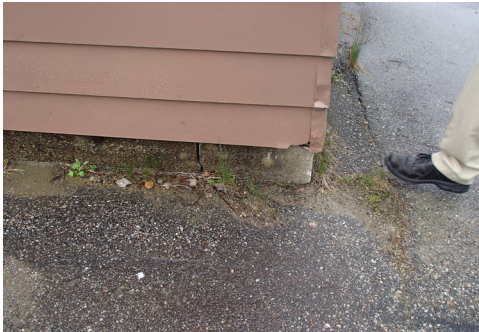
CORNER CRACK AT FOUNDATION

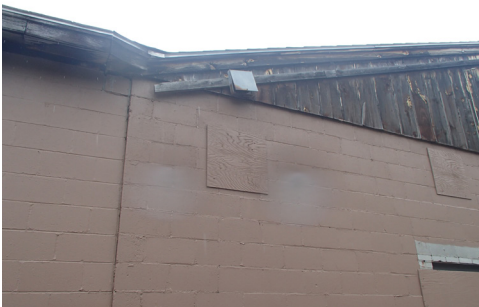
- Plywood coverings on abandoned windows are not sized properly and allow water intrusion behind.
- Building Interior**
  - Interior flooring, base, walls and ceiling are all worn and in need of repair/refinishing.

WEATHERED TRIM AT WINDOW BOARDING

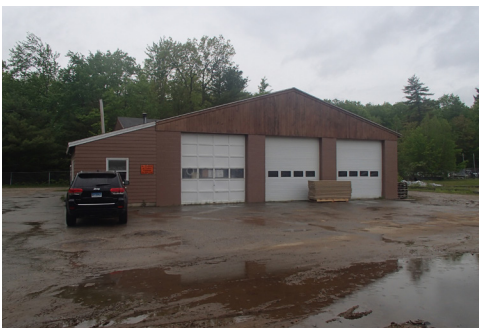
- Site**
  - Current parking is comprised of an undefined dirt area that is in need of grading.
  - Site is primarily dirt with blacktop drive at garage bays in need of repair.

DIRT AND PUDDLING AT SITE

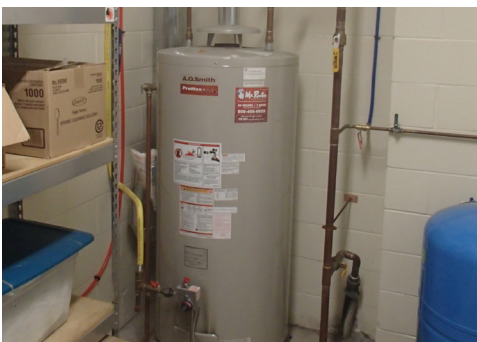
PLUMBING HOT WATER HEATER

Domestic cold water is provided from a well located near the driveway. Water for the pool system is provided from a well by the ball fields. Domestic hot water is generated from a propane gas-fire water heater installed in June 2017. The combustion air was report to be installed into the attic space. The hot water is tempered through a mixing valve located above the heater. Pool systems appear to be in good condition. Hose connections are provided around the building.

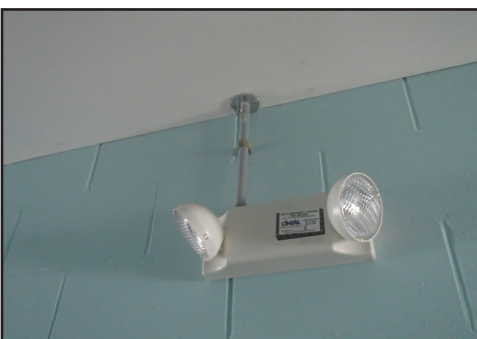
LIFE SAFETY

- Life Safety**
- No sprinkler system in the building.
  - Exit signs and fire horn/strobe devices appear to be in good condition and located as required.
  - Emergency lighting is located throughout building, but looks old. Not tested as part of this walk-through here is not a fire alarm panel, fire alarm is a series of local devices.

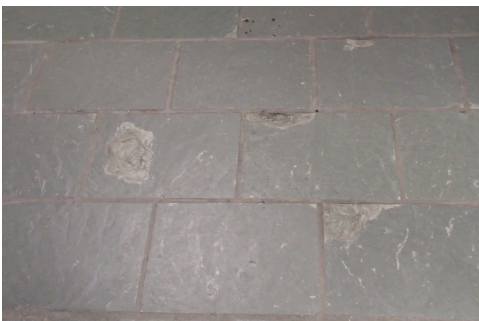
DAMAGE AT STONE FLOORING

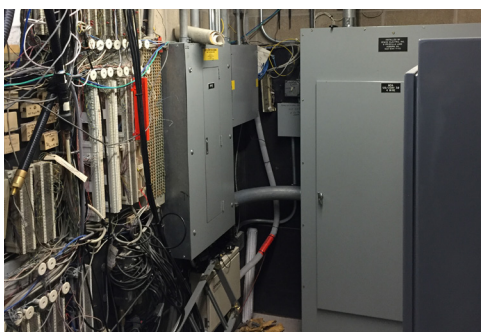
EXISTING ELECTRICAL

The electrical service entrance was upgraded with the addition of a larger generator. The working clearance does not meet the NEC which is a concern. A ground jumper should be installed across the water meter. Some lighting has been upgraded to LED type fixtures and this should continue. The exterior lighting has been fully upgraded and warrants no changes.

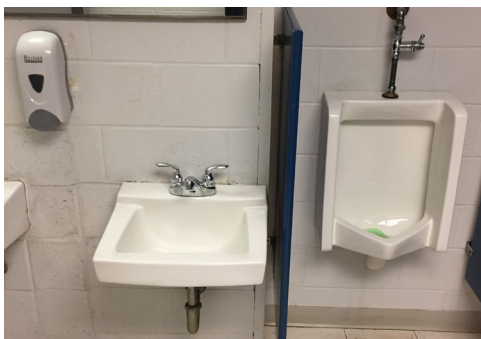
TYPICAL RESTROOM PLUMBING FIXTURES

- Plumbing**
  - Toilet fixture counts at restrooms and locker rooms do not meet occupant need.
  - Toilet lavatory drains require coverings.
  - Faucets with hose connections such as utility sink do not have vapor breaker backflow preventers.
  - Fluid draining from the double utility sink flows directly over the floor to the floor drain. Floor drain is showing signs of corrosion.

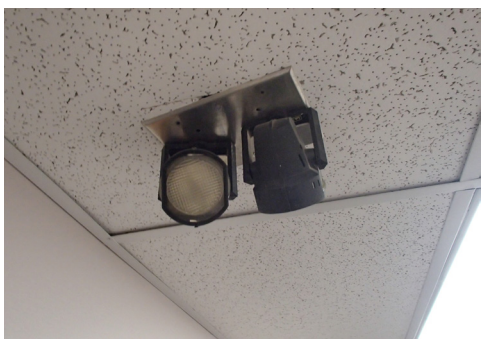
LIFE SAFETY

The fire alarm system is an older Notifier addressable panel. Emergency lighting should be added to the truck bays.

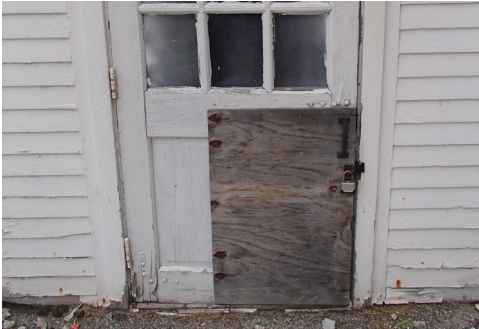
- Building Envelope**
  - Concrete, stone and CMU foundations appear in acceptable condition.
  - Wood clapboard siding and trim in need of repair and paint especially at doors and grade.
  - Windows are original and not weather tight and need re-glazing.
  - Roof showing signs of rippling and wear.
  - Many exterior doors in need of repair and showing signs of corrosion.

DAMAGED DOOR

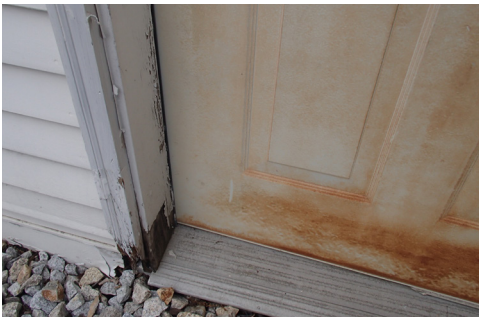
DOOR CORROSION

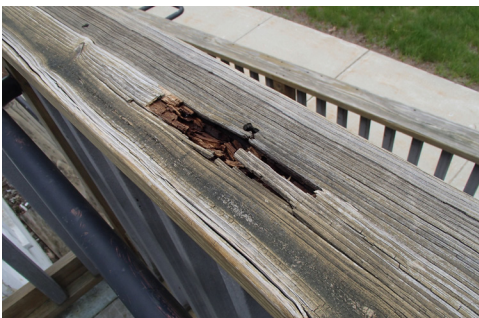
- Site**
  - Entry stairs show signs of spalling and some previous repairs.
  - Wood rot is evident on the accessible ramp guard components.

ROT AT WOOD HANDRAIL AT RAMP

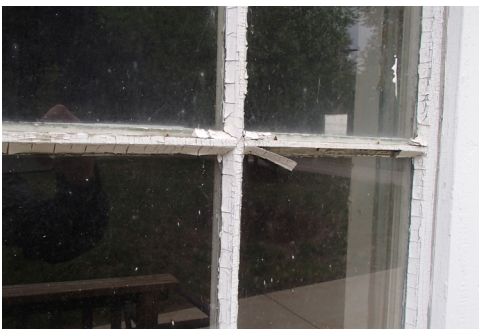
WINDOWS NEED REGLAZING

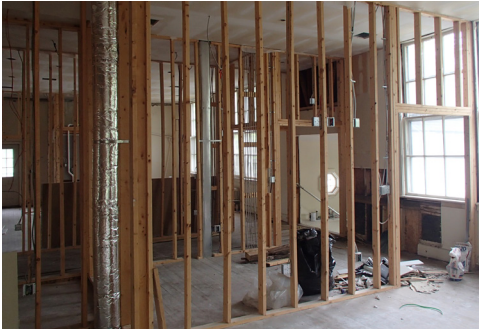
- Building Interior**
  - All interior conditions are noted as ‘poor’ due to the current state of construction at all interior spaces.
  - Rough framed interior partitions are a mix of existing wood lath and plaster with new stud framing.

This building is currently in a state of construction. New interior partition framing is in place, but little else. Interior finishes are non-existent at this time.

TYPICAL INTERIOR CONSTRUCTION

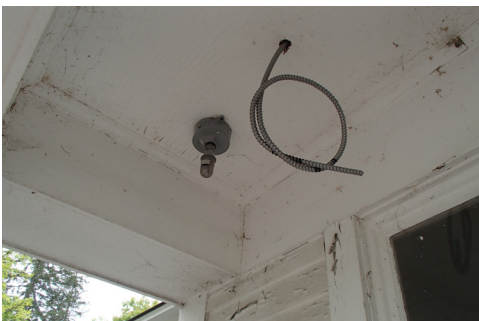
EXPOSED ELECTRICAL

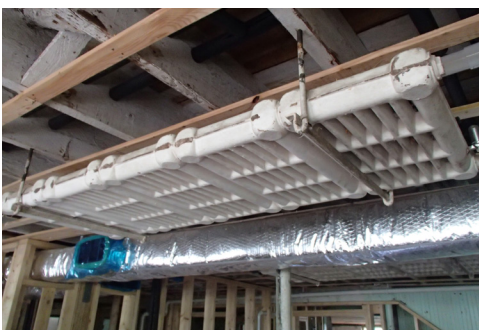
OLD AND NEW MECHANICAL SYSTEMS

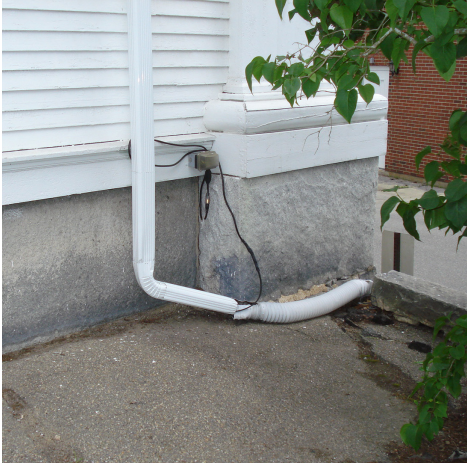
RAIN LEADER AND DOWNSPOUT

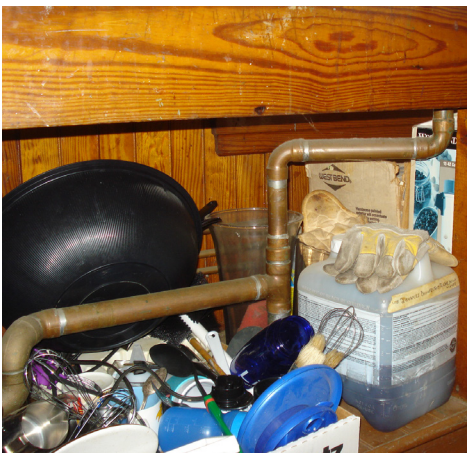
- Many plumbing pipes and valves not concealed in wall.
- Backflow preventers are not installed at faucet hose connection.
- Water entrance is showing signs of corrosion toilet in basement is showing signs of backflow and appears to be abandoned.
- Sump pump is showing signs of its age.

KITCHEN PIPING

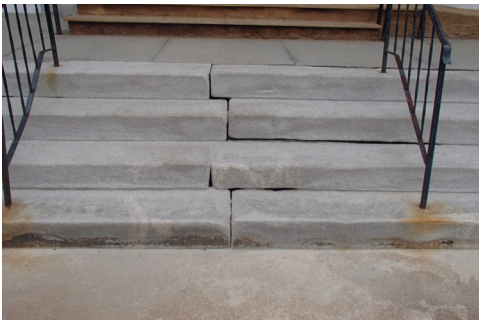
- Site**
- Concrete stairs and front entrance are crumbling and appear unusually weather-worn. Front stairs have large openings allowing water intrusion and freeze/thaw issues
  - Wooden stair and ramp from stone porch to front entry door unusually worn – perhaps from salt
  - ADA ramp has many structural cracks and heaving. Railing system shows extensive signs of corrosion.
  - Granite retaining walls, porches and foundation/veneers need repointing and realignment at various spot around the site.

CORROSION AT ENTRANCE CONCRETE STAIR AND WOOD RAMP

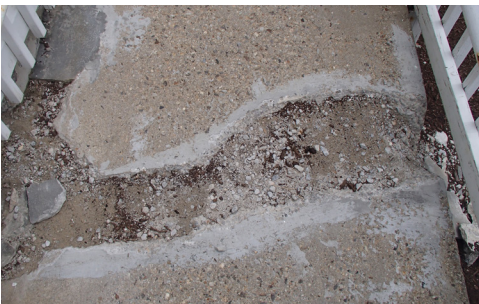
DAMAGE AT ADA ENTRY RAMP

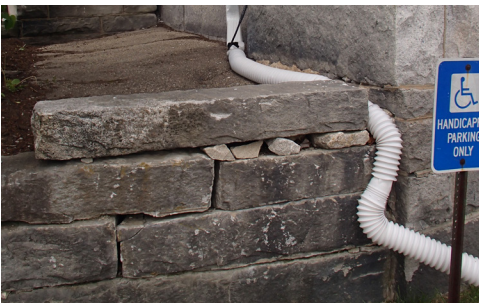
REPOINTING REQUIRED AT GRANITE

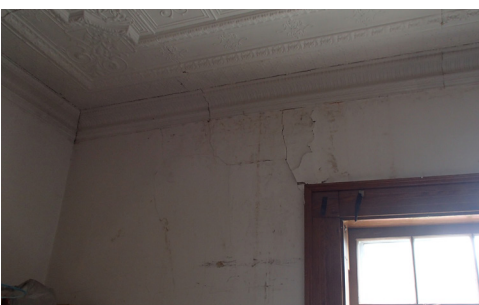
- Building Interior**
- Walls were in need of refinishing (Paint/stain, urethane)
  - Flooring was worn and in need of refinishing at entrance lobby, kitchen, stairways and auditorium. Bathroom VCT cracked and discolored.
  - Handrails were not ADA or code compliant (only 29” AFF)
  - Water damage observed at plaster walls in several locations.
  - Evidence of water infiltration at floor of basement at double doors on east side of building.

WATER DAMAGE AT INTERIOR WALLS

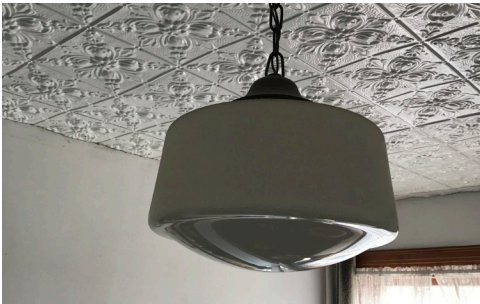
EXISTING LIGHTING

Recent upgrades to the existing electrical system were observed. Fluorescent fixtures are old but appear to be in working order, to reduce maintenance and energy cost new technologies (LED lighting) should be considered.

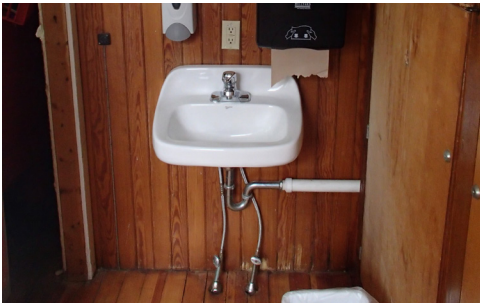
EXPOSED PLUMBING

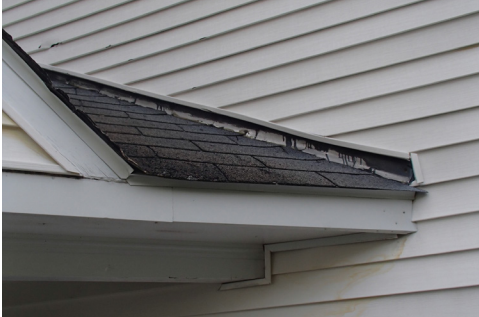
WORN ROOFING & FLASHING

The asphalt shingle roof is in fair condition with areas of discoloration. Flashing elements are in fair to poor condition with concern focused at connections to vinyl siding termination strips and roof penetrations.

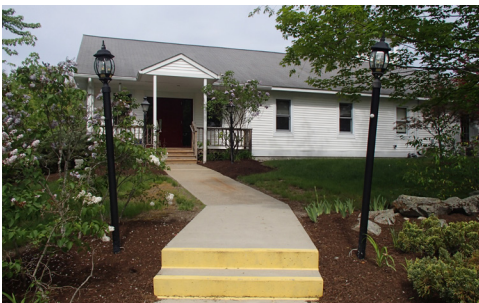
- ‘Porch’ at secondary entrance to town manager’s office is not ADA compliant - handrails and guard.
  - Soffit vents show sign of damage in wood soffits.

BUILDING EXTERIOR - NON-COMPLIANT BUILDING ACCESS

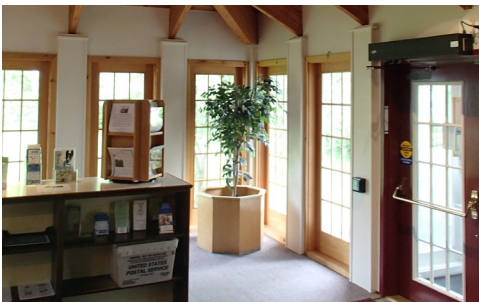
- Building Interior**
- Interior finishes in corridors and offices are in good condition overall and appear to be recently installed.
  - Resilient flooring in main lobby (now covered with walk-off mat) shows heavy signs of wear and requires replaconcrete.

INTERIOR LOBBY FINISHES WORN & WORN FLOORING UNDER WALK OFF MAT

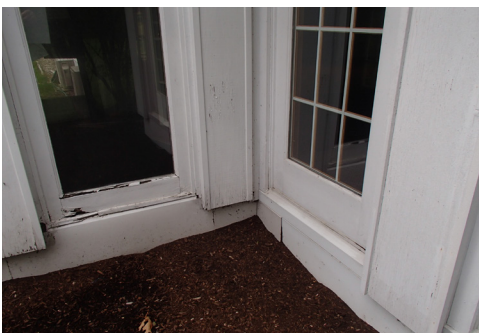
- Wood soffit requires repainting.
  - Window at front entrance vestibule rotted at water table level.
  - Doors at lower level in need of paint and frames have some rot/rust.

WATER DAMAGE AT WATER TABLE

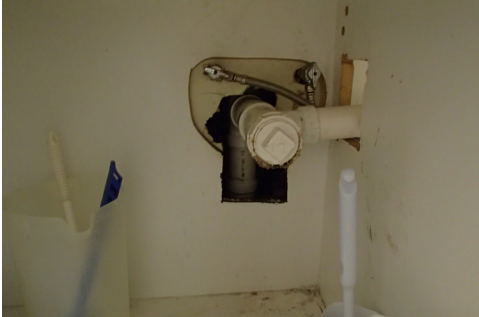
- Toilet vanities show signs of water infiltration as backsplash and wall.
  - Several toilets have been replaced without proper painting of wall behind leaving ‘shadow’ of old toilet bowl.

TYPICAL TOILET ROOM PLUMBING

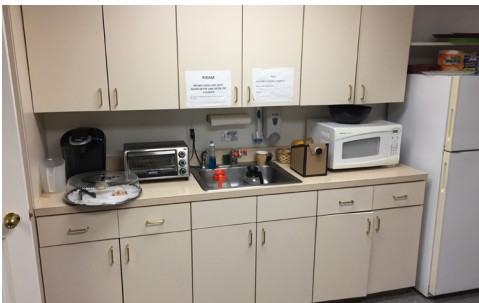
- Users complained of periodic smell of sewage.
- At the time of review repairs to the break room sink were being made to clear obstructions.

BREAK ROOM PLUMBING

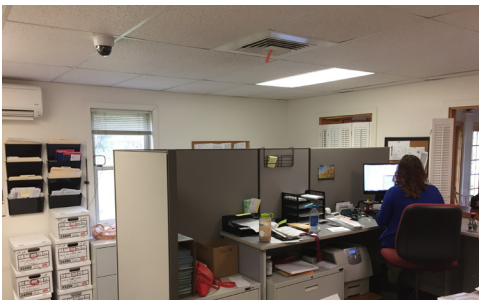
The building utilizes a 50kW emergency generator powered by an underground propane tank. The service entrance panels appear in relatively good working condition. Fluorescent fixtures appear to be in good working order, to reduce maintenance (the 39 watt ballasts are expensive) and energy cost new technologies (LED lighting) should be considered. Incandescent downlights have retrofit fluorescent lamps installed, consideration should be given either to replace the fixture or add an LED retrofit kit to the existing fixture.

TYPICAL EXISTING LIGHTING,  
SURVEILLANCE CAMERA, & HVAC

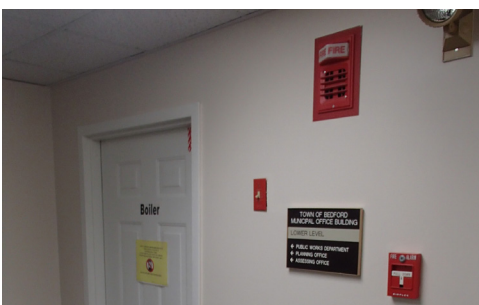
Emergency lighting exists throughout the building however battery pack units are older and should be replaced. Horn strobes, pull stations, and fire alarm control panels are all in relatively good working condition.

HORN STROBE, PULL STATION,  
AND OLDER EMERGENCY LIGHTING

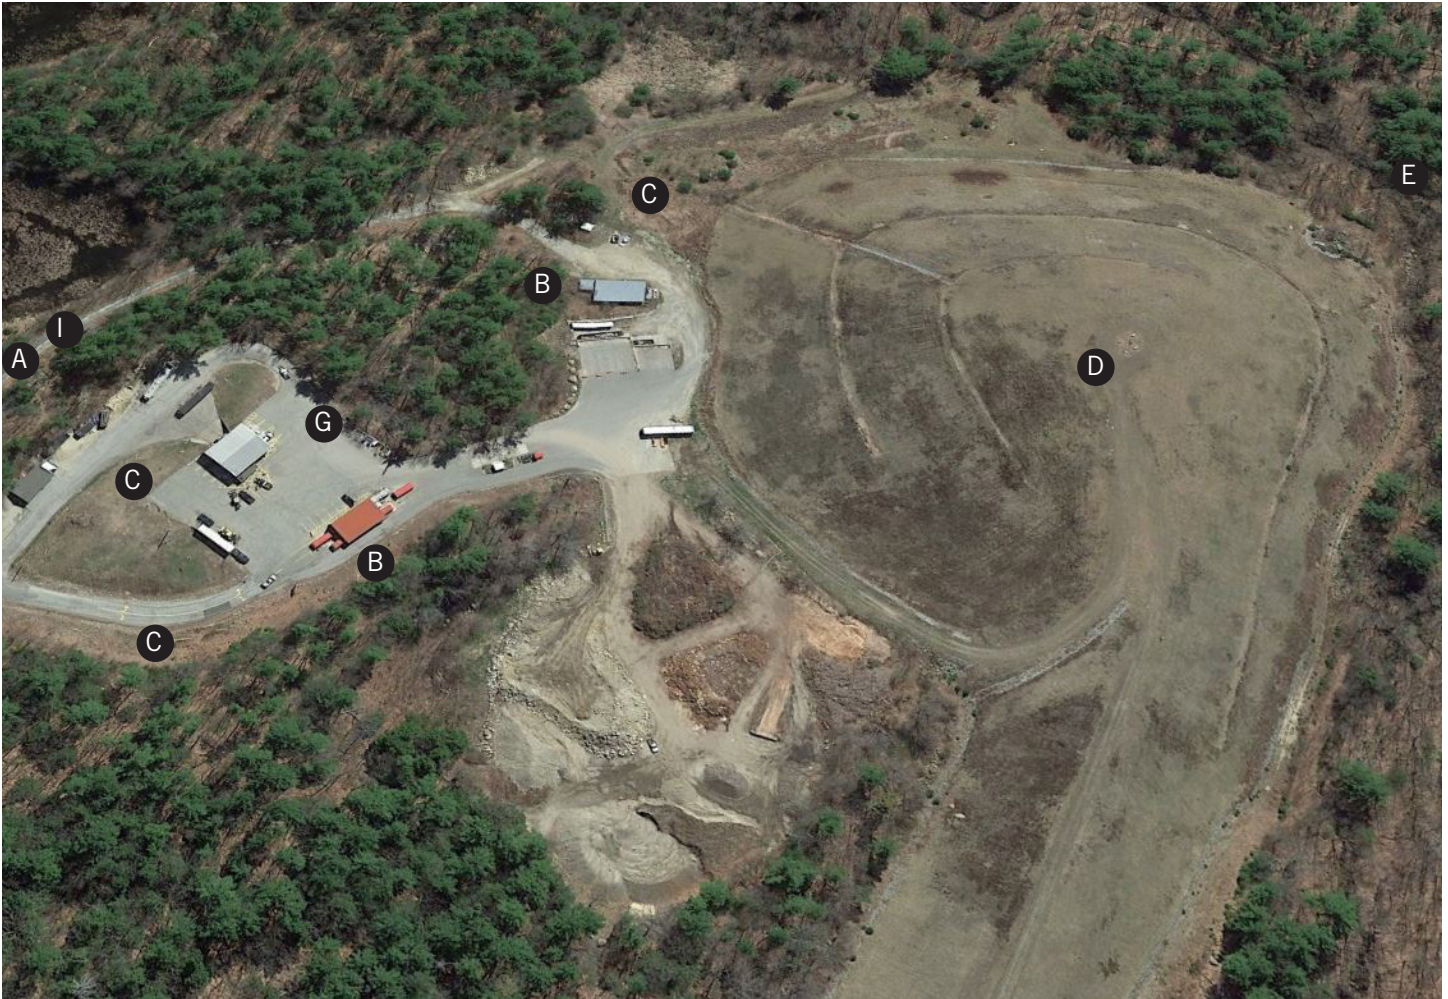
Key Noted Site Plan: See 'Site Issues, Needs, and Observations'

| <b>Context, Access and Circulation</b> | <ul style="list-style-type: none"> <li>A. The Transfer Station is located on Chubbuck Rd that is served by Wallace Rd. The single access drive causes traffic delays during weekend hours.</li> <li>B. In addition to the transfer station, the site is occupied by a cluster of small buildings. These include a recycling center, swap shop, and police vehicle impound area.</li> <li>C. Site service areas include a masonry dump, soil and vegetative debris areas storing material to be recycled and repurposed.</li> </ul> |
| <b>Site Features and Improvements</b> | <ul style="list-style-type: none"> <li>F. The vehicular circulation is constricted by the dead-end road access.</li> <li>G. Vehicular circulation crosses the same locations required for the replacement of trash trailers resulting in safety concerns.</li> </ul> |
| <b>Opportunities and Constraints</b> | <ul style="list-style-type: none"> <li>I. Access and Context – the site has one access and egress to Chubbuck Rd. which in causes traffic congestion during busy weekend hours.</li> <li>J. On-site vehicular conflicts with maintenance needs has created safety concerns.</li> <li>K. Future Expansion on-site – the site is constrained by the existing capped landfills, steep slopes and further expansion of activities will have to continue to address noise impacts on adjacent neighborhoods.</li> </ul> |

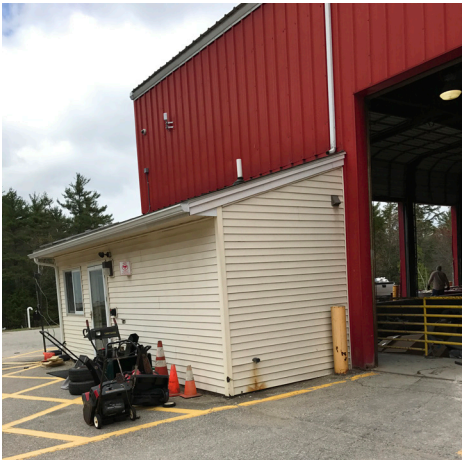
- All finishes and systems in the office area are in need of repair or replacement.
- Dumpster bay has insulation picked at and worn, perhaps by wildlife.
- Guardrails along bays need to be refinished.
- All interior walls/ceilings, flooring, base and doors are dirty, worn, and in need of cleaning/repair and refinishing.
- Horizontal ledge along truck bays collecting garbage and not allowing it to slide into bin below.
- The main portions of the building are basically open to the elements and serve their industrial purpose in this manner.
- The toilet is also serving as a janitor closet and storage room. The toilet has handrails, but ADA clearances are not met. There is a need for additional counter space in the office as this also serves as the staff break area.

EXTERIOR OFFICE

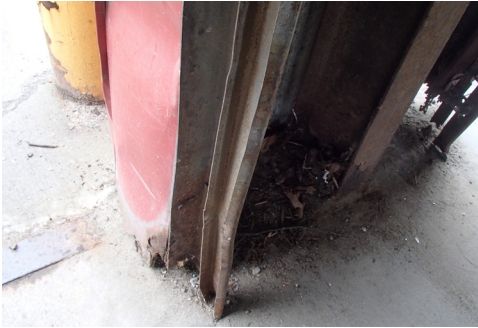
- Exposed foundation is pitted and showing signs of elemental exposure.
- Siding and doors are damaged from vehicular and equipment collisions. Steel siding is showing signs of corrosion at grade.
- Large opening in panel joints are observed in several locations.
- Windows are in need of resealing.
- Recycle station is open to elements with no means of closing and securing the building.
- Openings are cut into metal sheathing and not framed openings leading to deformity in the walls.
- Bollards at all locations are showing signs of corrosion and need to be refinished.

CORROSION AT DOOR FRAMES

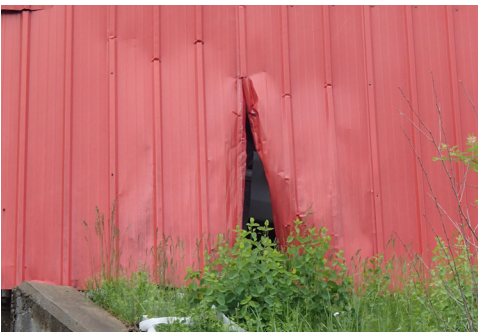
OPENING IN METAL PANEL SIDING

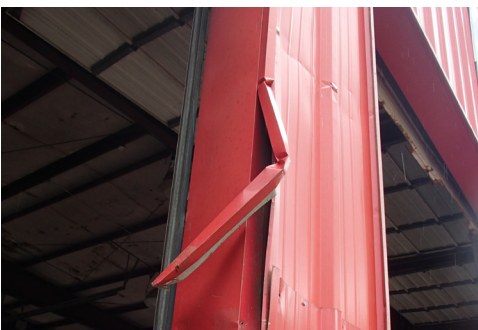
VEHICLE DAMAGE AT DOOR  
GARAGE OPENING

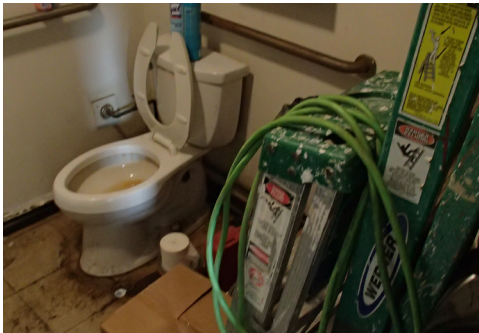
TYPICAL RESTROOM PLUMBING FIXTURES

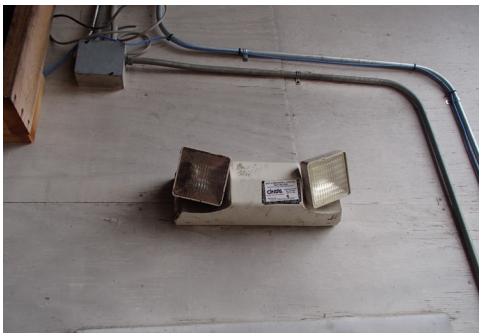
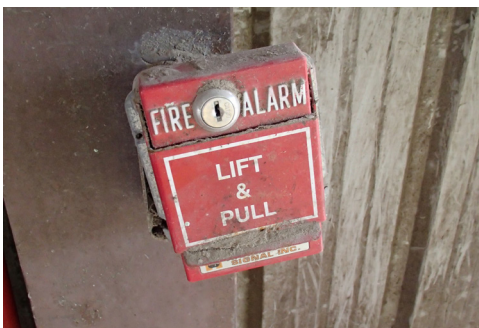
- Life Safety**
- Facility is not sprinklered, but other life safety devices appear to be installed as required.
  - Emergency battery units installed in the trash room appear to be exposed to extreme temperatures this would have an impact on the battery life.
  - Fire alarm system is a zoned conventional system
- Mechanical**
- The single enclosed and conditioned space is the manager's office which consists of the office and the adjoining restroom.
  - A new repla concrete exhaust fan was observed.
- Plumbing**
- Plumbing fixtures are appropriate for this type of facility.
- Electrical**
- Single PV cell on roof of office area.

LIFE SAFETY
